A Case Study of Dynamic Instability in a Planing Hull

Louis Codega¹ and James Lewis¹

Soon after introduction into service, a class of high-speed planing boats began to exhibit a dynamic instability that manifested itself in the craft trimming by the bow, rolling to a large angle of heel to port, and broaching violently to starboard, all within five seconds. This behavior, which occurred within the craft's normal operating envelope, could not be attributed to operator causes and resulted in unacceptable operating restrictions being placed on the craft. After a number of unsuccessful attempts to remedy the problem, an investigation to research possible causes was undertaken. Concurrently, a test boat was instrumented to quantify its behavior and, most importantly, to record the hydrodynamic bottom pressures acting while this phenomenon occurs. The craft is described and initial attempts at solving the problem are outlined. The results of research on this type of phenomena in both planing craft and flying boats are presented. The instrumentation system, complex for this size craft, is detailed and the test procedure described. The results of the full-scale tests are given, along wit

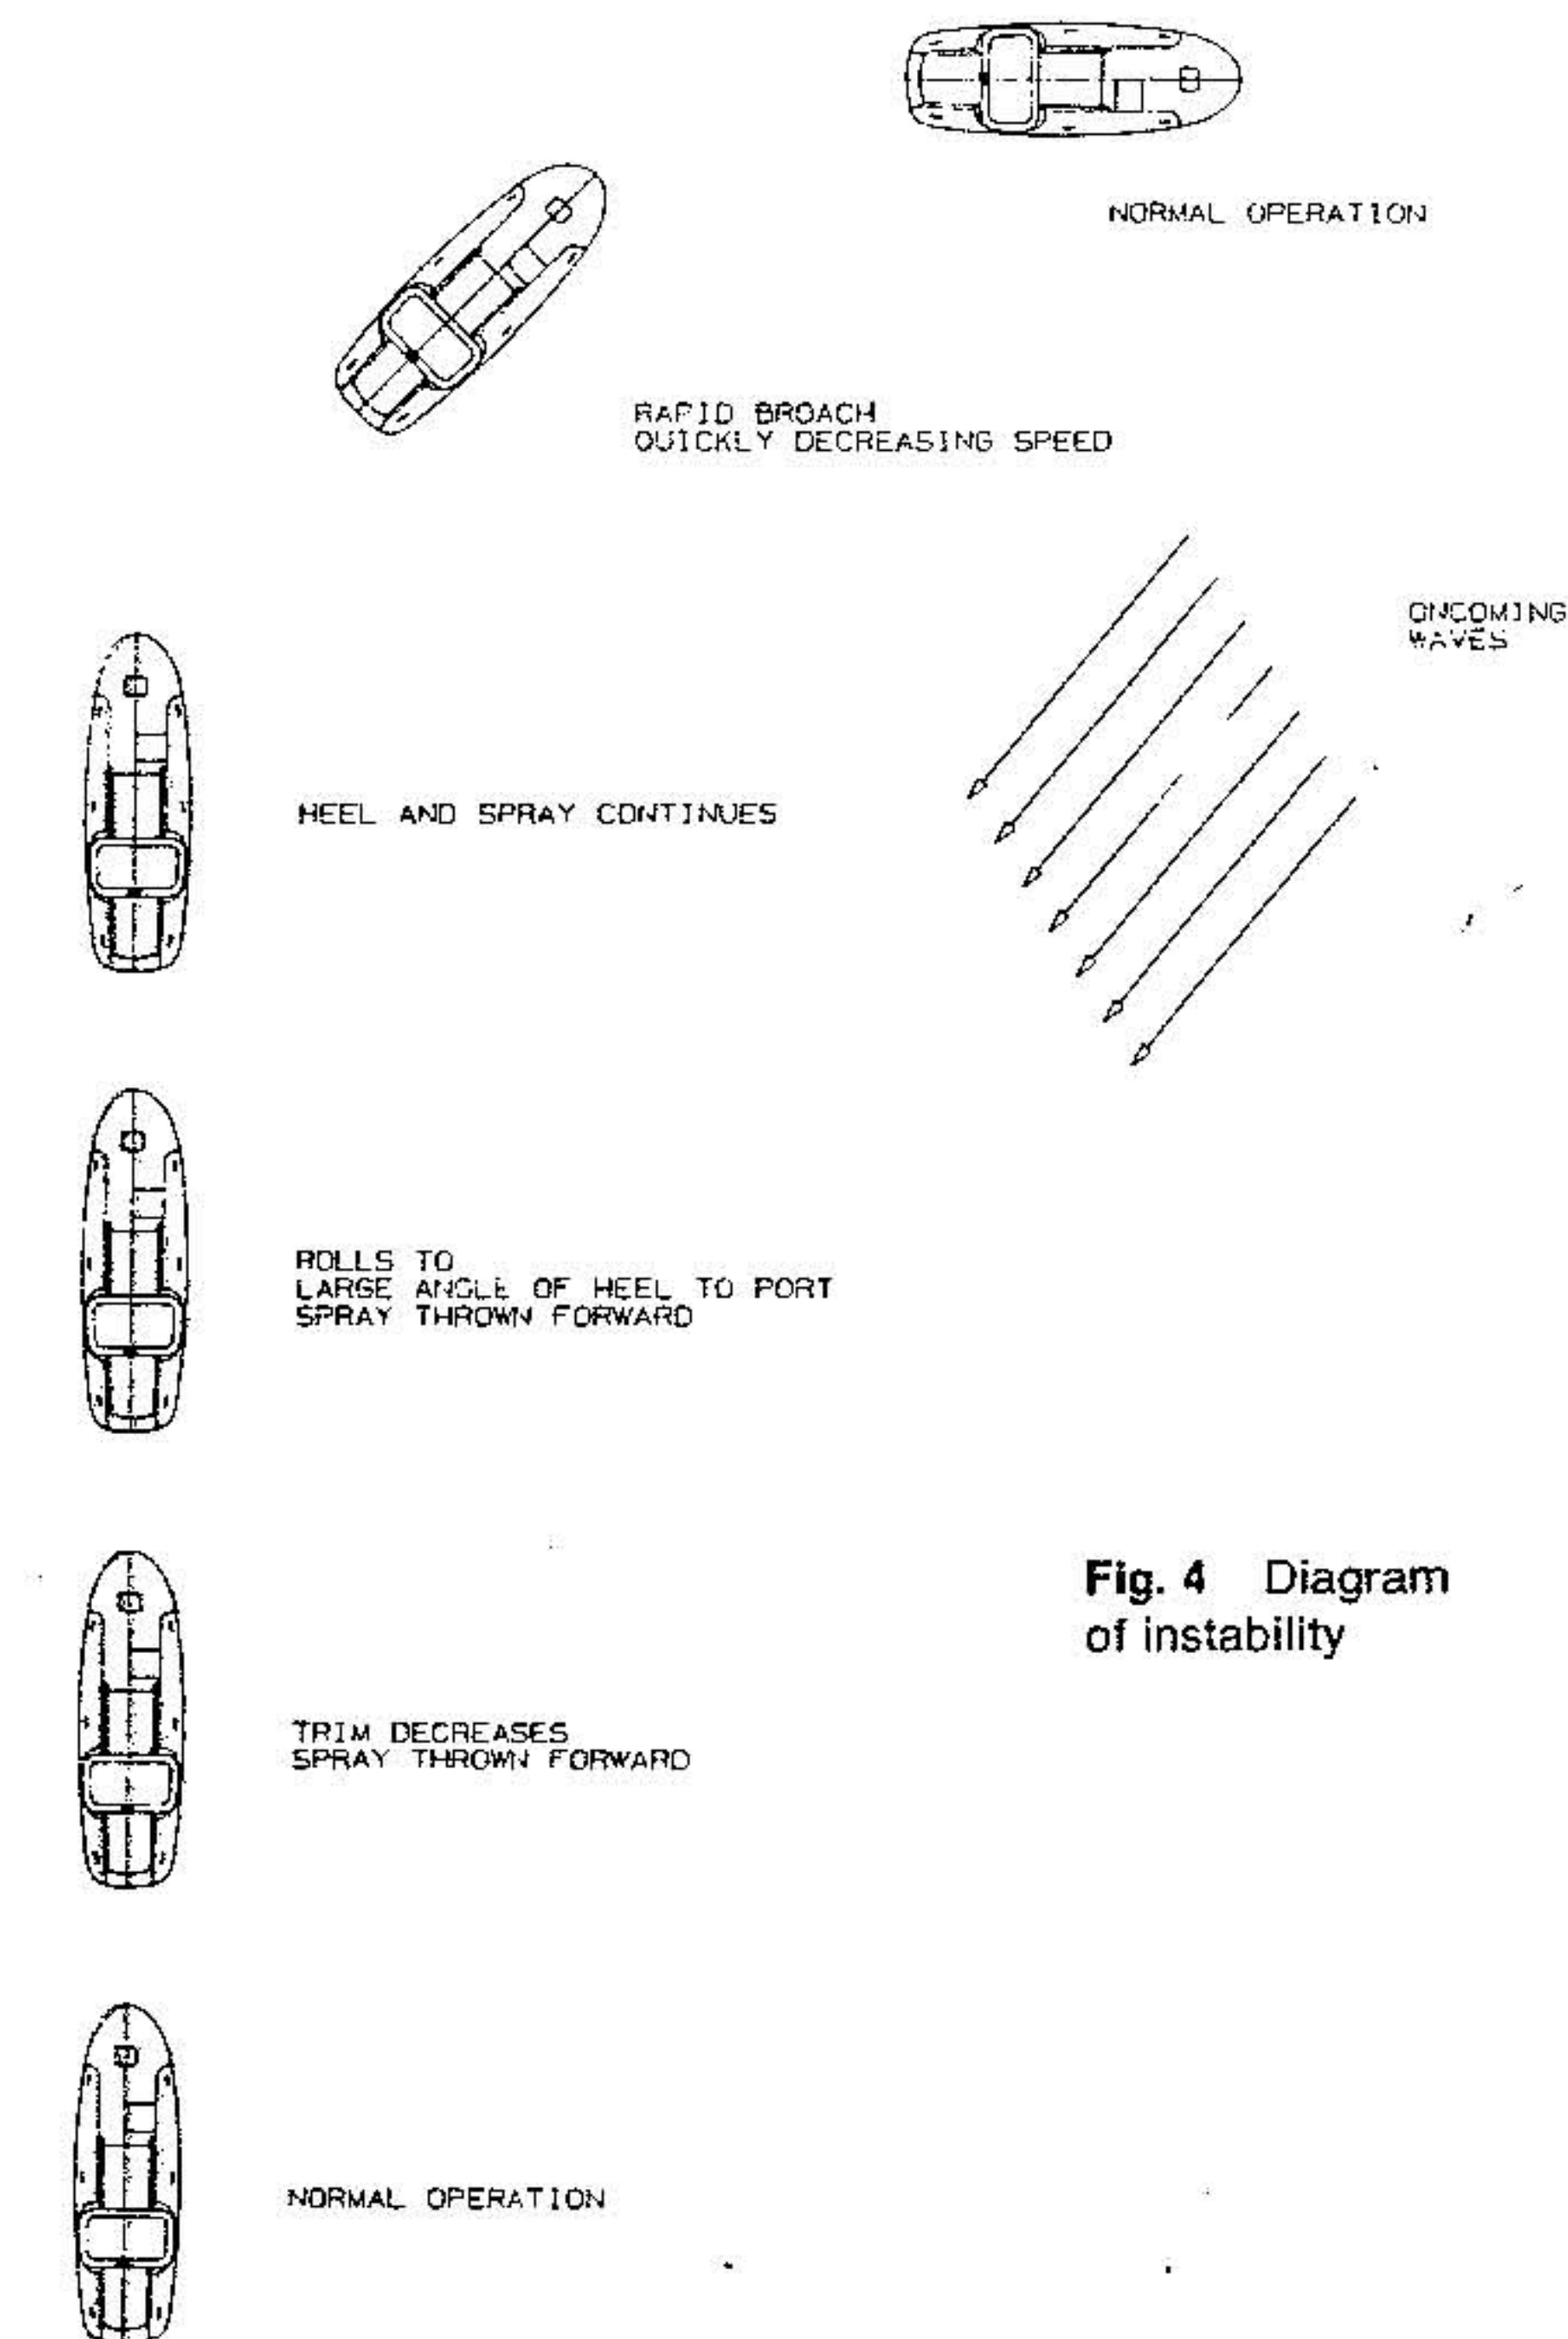
Fig. 4 Diagram of instability

The craft proved to be highly successful and in many ways exceeded the operator's requirements, except in one very important regard. When operating at high speed in waves, the lead boat exhibited an unstable behavior that occurred in two ways. One was described as a decrease in running trim accompanied by large amounts of spray being thrown forward. The most common manifestation, though, was a violent roll, generally to

port and reportedly of up to 90 deg, followed by an equally severe broach away from the roll, usually to starboard. During one of these occurrences, the crew was thrown completely clear of the boat. The Coast Guard immediately began an investigation of the problem and were successful in lessening the rate of occurrences, but were not able to either develop a completely satisfactory explanation or eliminate its occurrence.

It was found that the boat was somewhat stable while in the "unstable" condition, running at a reduced trim angle, heeled over, usually to port as much as 60 deg and throwing large quantities of spray forward, blinding the crew and obscuring the boat from view. The rudder had no predictable effect on the craft, but the helmsman had some degree of control in that increased throttle forced the boat to a larger angle of heel and reduced throttle resulted in less heel or coming out of the mode completely. If the angle of roll became too great, the craft would broach violently. With practice the coxswains became proficient at keeping the boat in this bow-down, heeled-over condition for periods of up to a minute.

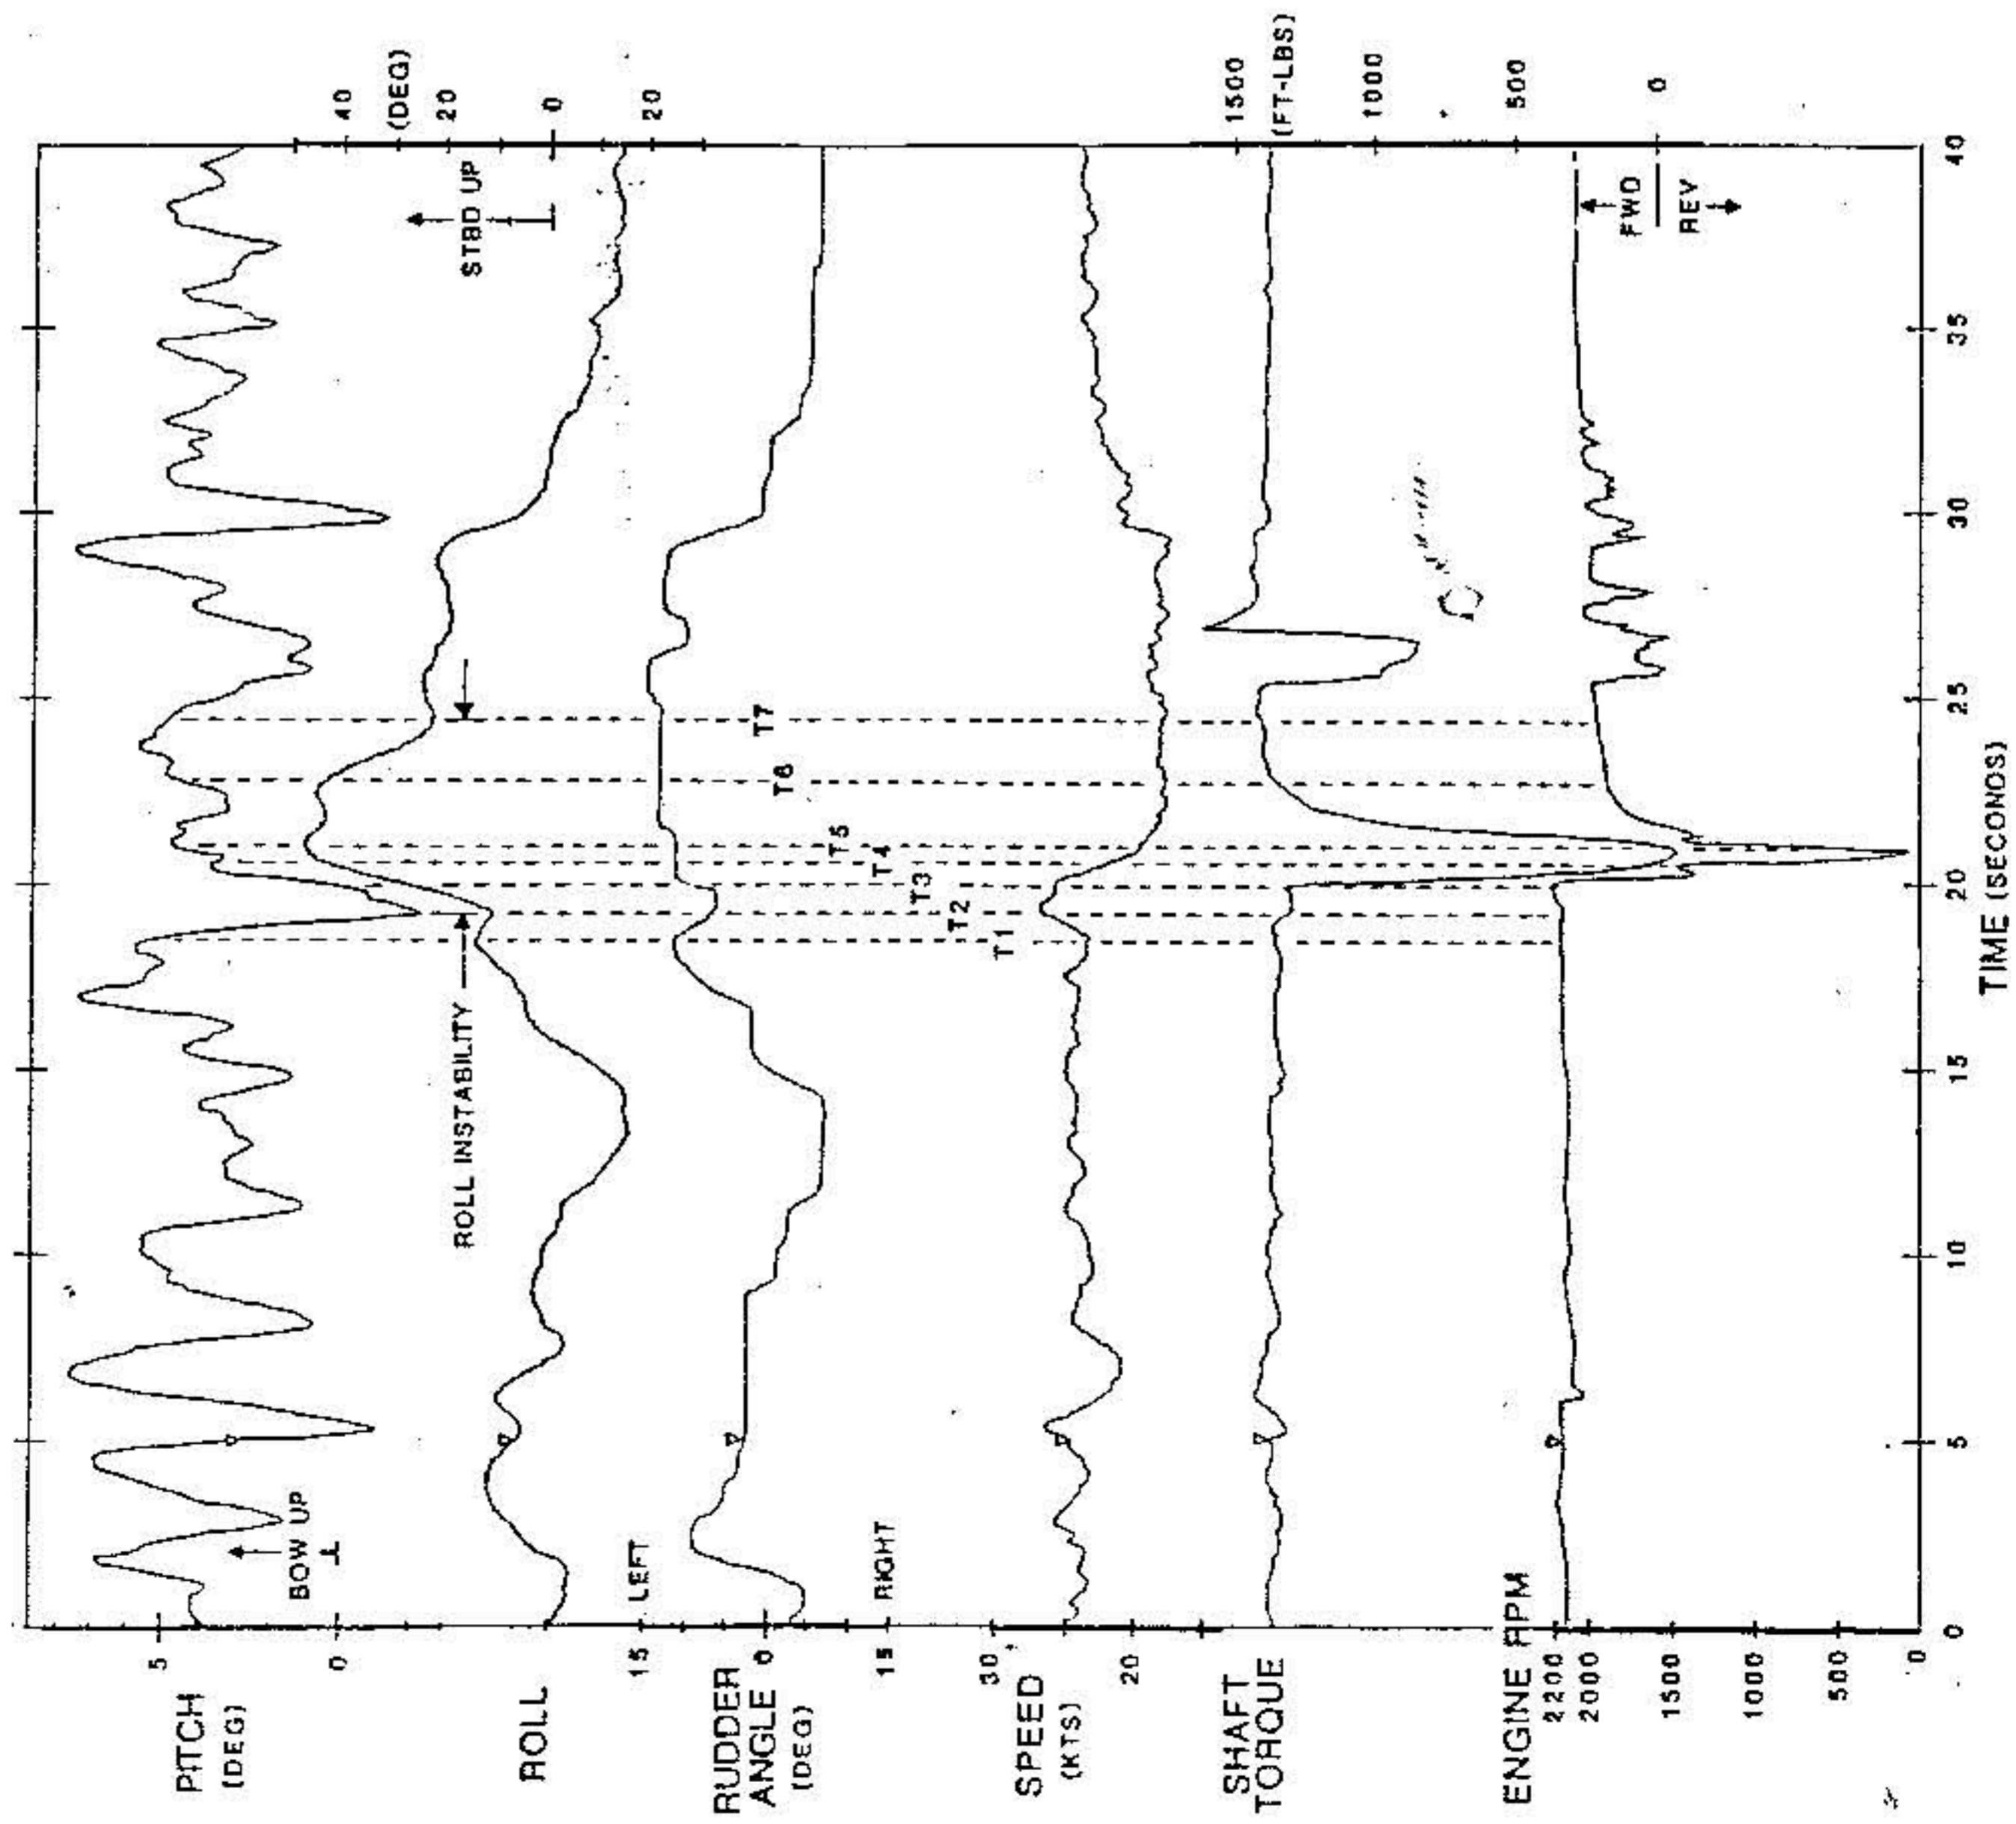
Fig. 17 Recorded data showing roll instability

The recorded data show negative pressures developing along the port bow when the instability takes place. Figures 17 through 28 show 40 sec of actual data recorded during which a roll instability occurred and lasted for approximately 5 sec. The following paragraphs give an interpretation of the data and reconstruct the events that occurred prior to, at the onset of, and during the instability. Data from pressure transducers Nos. 9 and 11 are omitted due to transducer failure. Figures 29 and 30 show pictorial views of the bottom pressure distribution at the time the instability occurred. The size of the pressure arrows in Figs. 29 and 30 indicates pressure magnitude. "T1" through "T7" refer to time events labeled on the data plots.

T1 (pre-instability condition). At time T1 on the data plots the boat is traveling at a speed of 24 knots. It has just stopped rolling 17 deg to port in response to an 11-deg left rudder command. The coxswain starts centering the rudder and the roll angle starts decreasing. The pitch data show that the bow has started a downward motion. All pressure transducers forward of pressure transducer No. 8 are at atmospheric pressure, indicating that the bow forward of station $4\frac{1}{2}$ is clear of the water. Pressure transducer No. 8 shows a high pressure (greater than 4 psi), indicating a close proximity to the flow stagnation line. Pressure transducer No. 4 located 2 ft aft of transducer No. 8 shows an increasing pressure, indicating that the center of pressure is moving aft. Immediately after T1 the boat speed

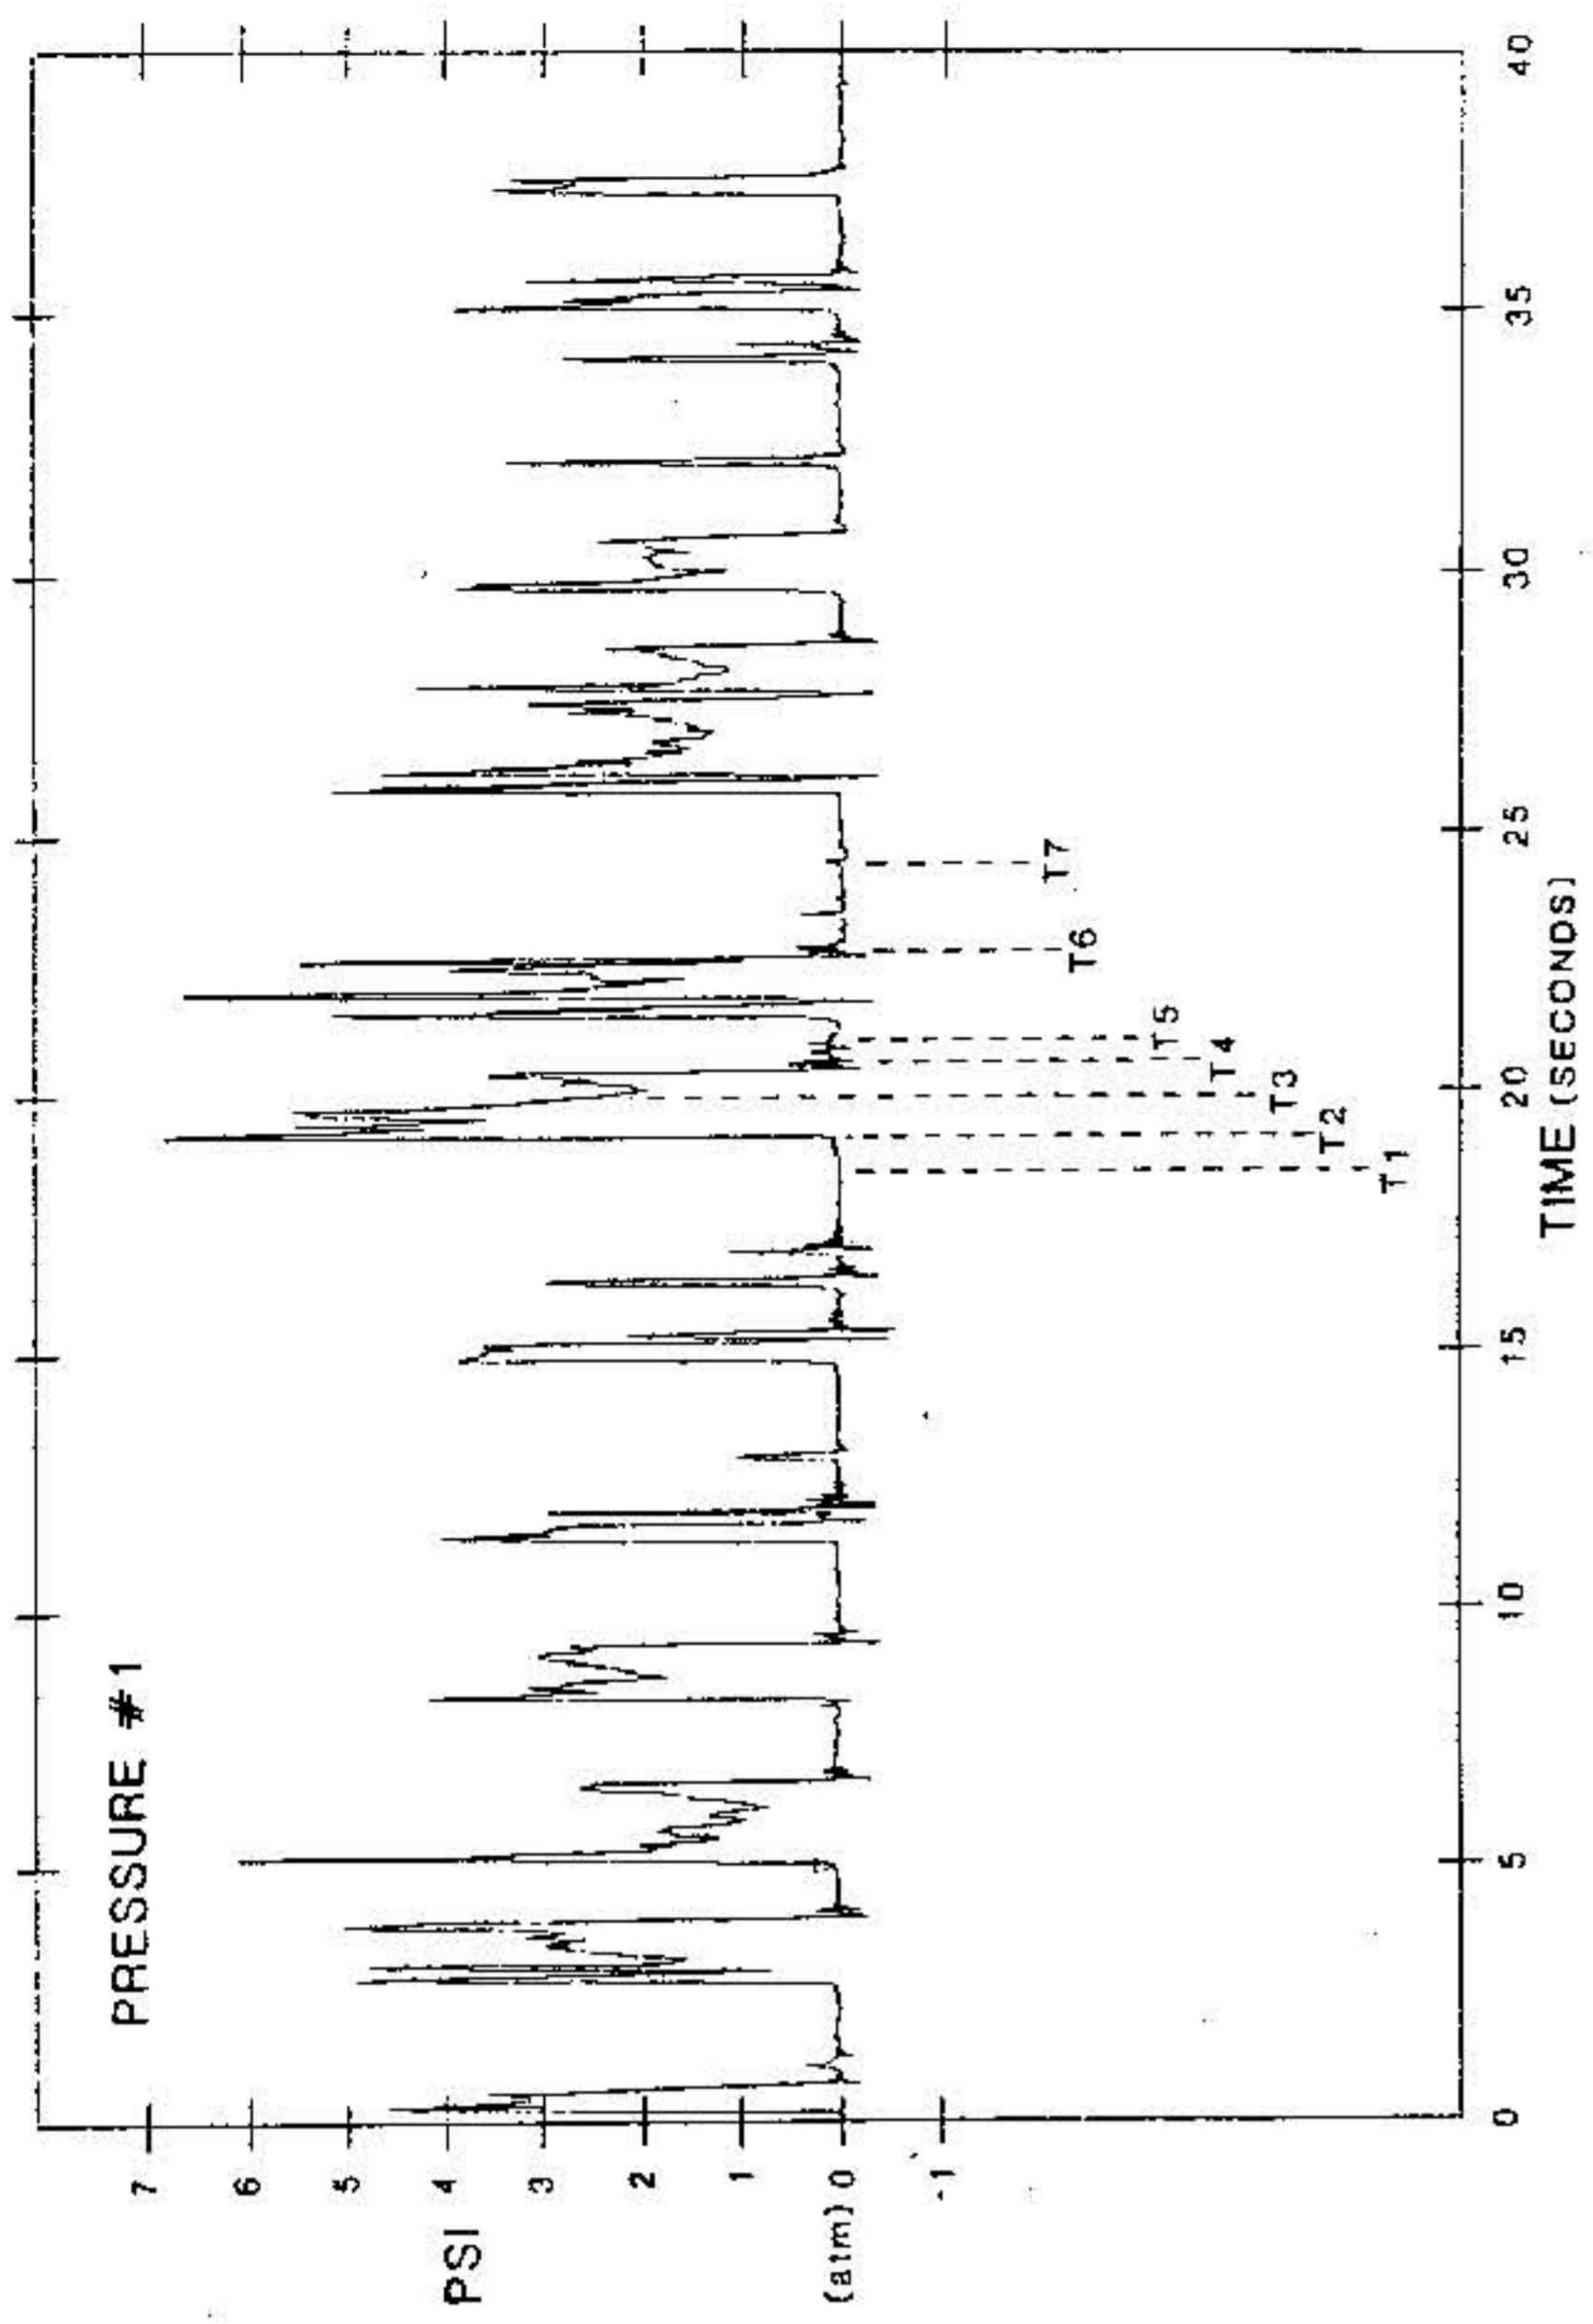
Fig. 18 Recorded data for pressure transducer No. 1

T6 (negative pressures decrease). At time T6 pressure transducer No. 1 clears water again. The -2.5 psi pressure at transducer No. 8 decreases to -1 psi and the negative pressures at Nos. 2 and 3 start decreasing. The roll decreases from 45 to 21 deg.

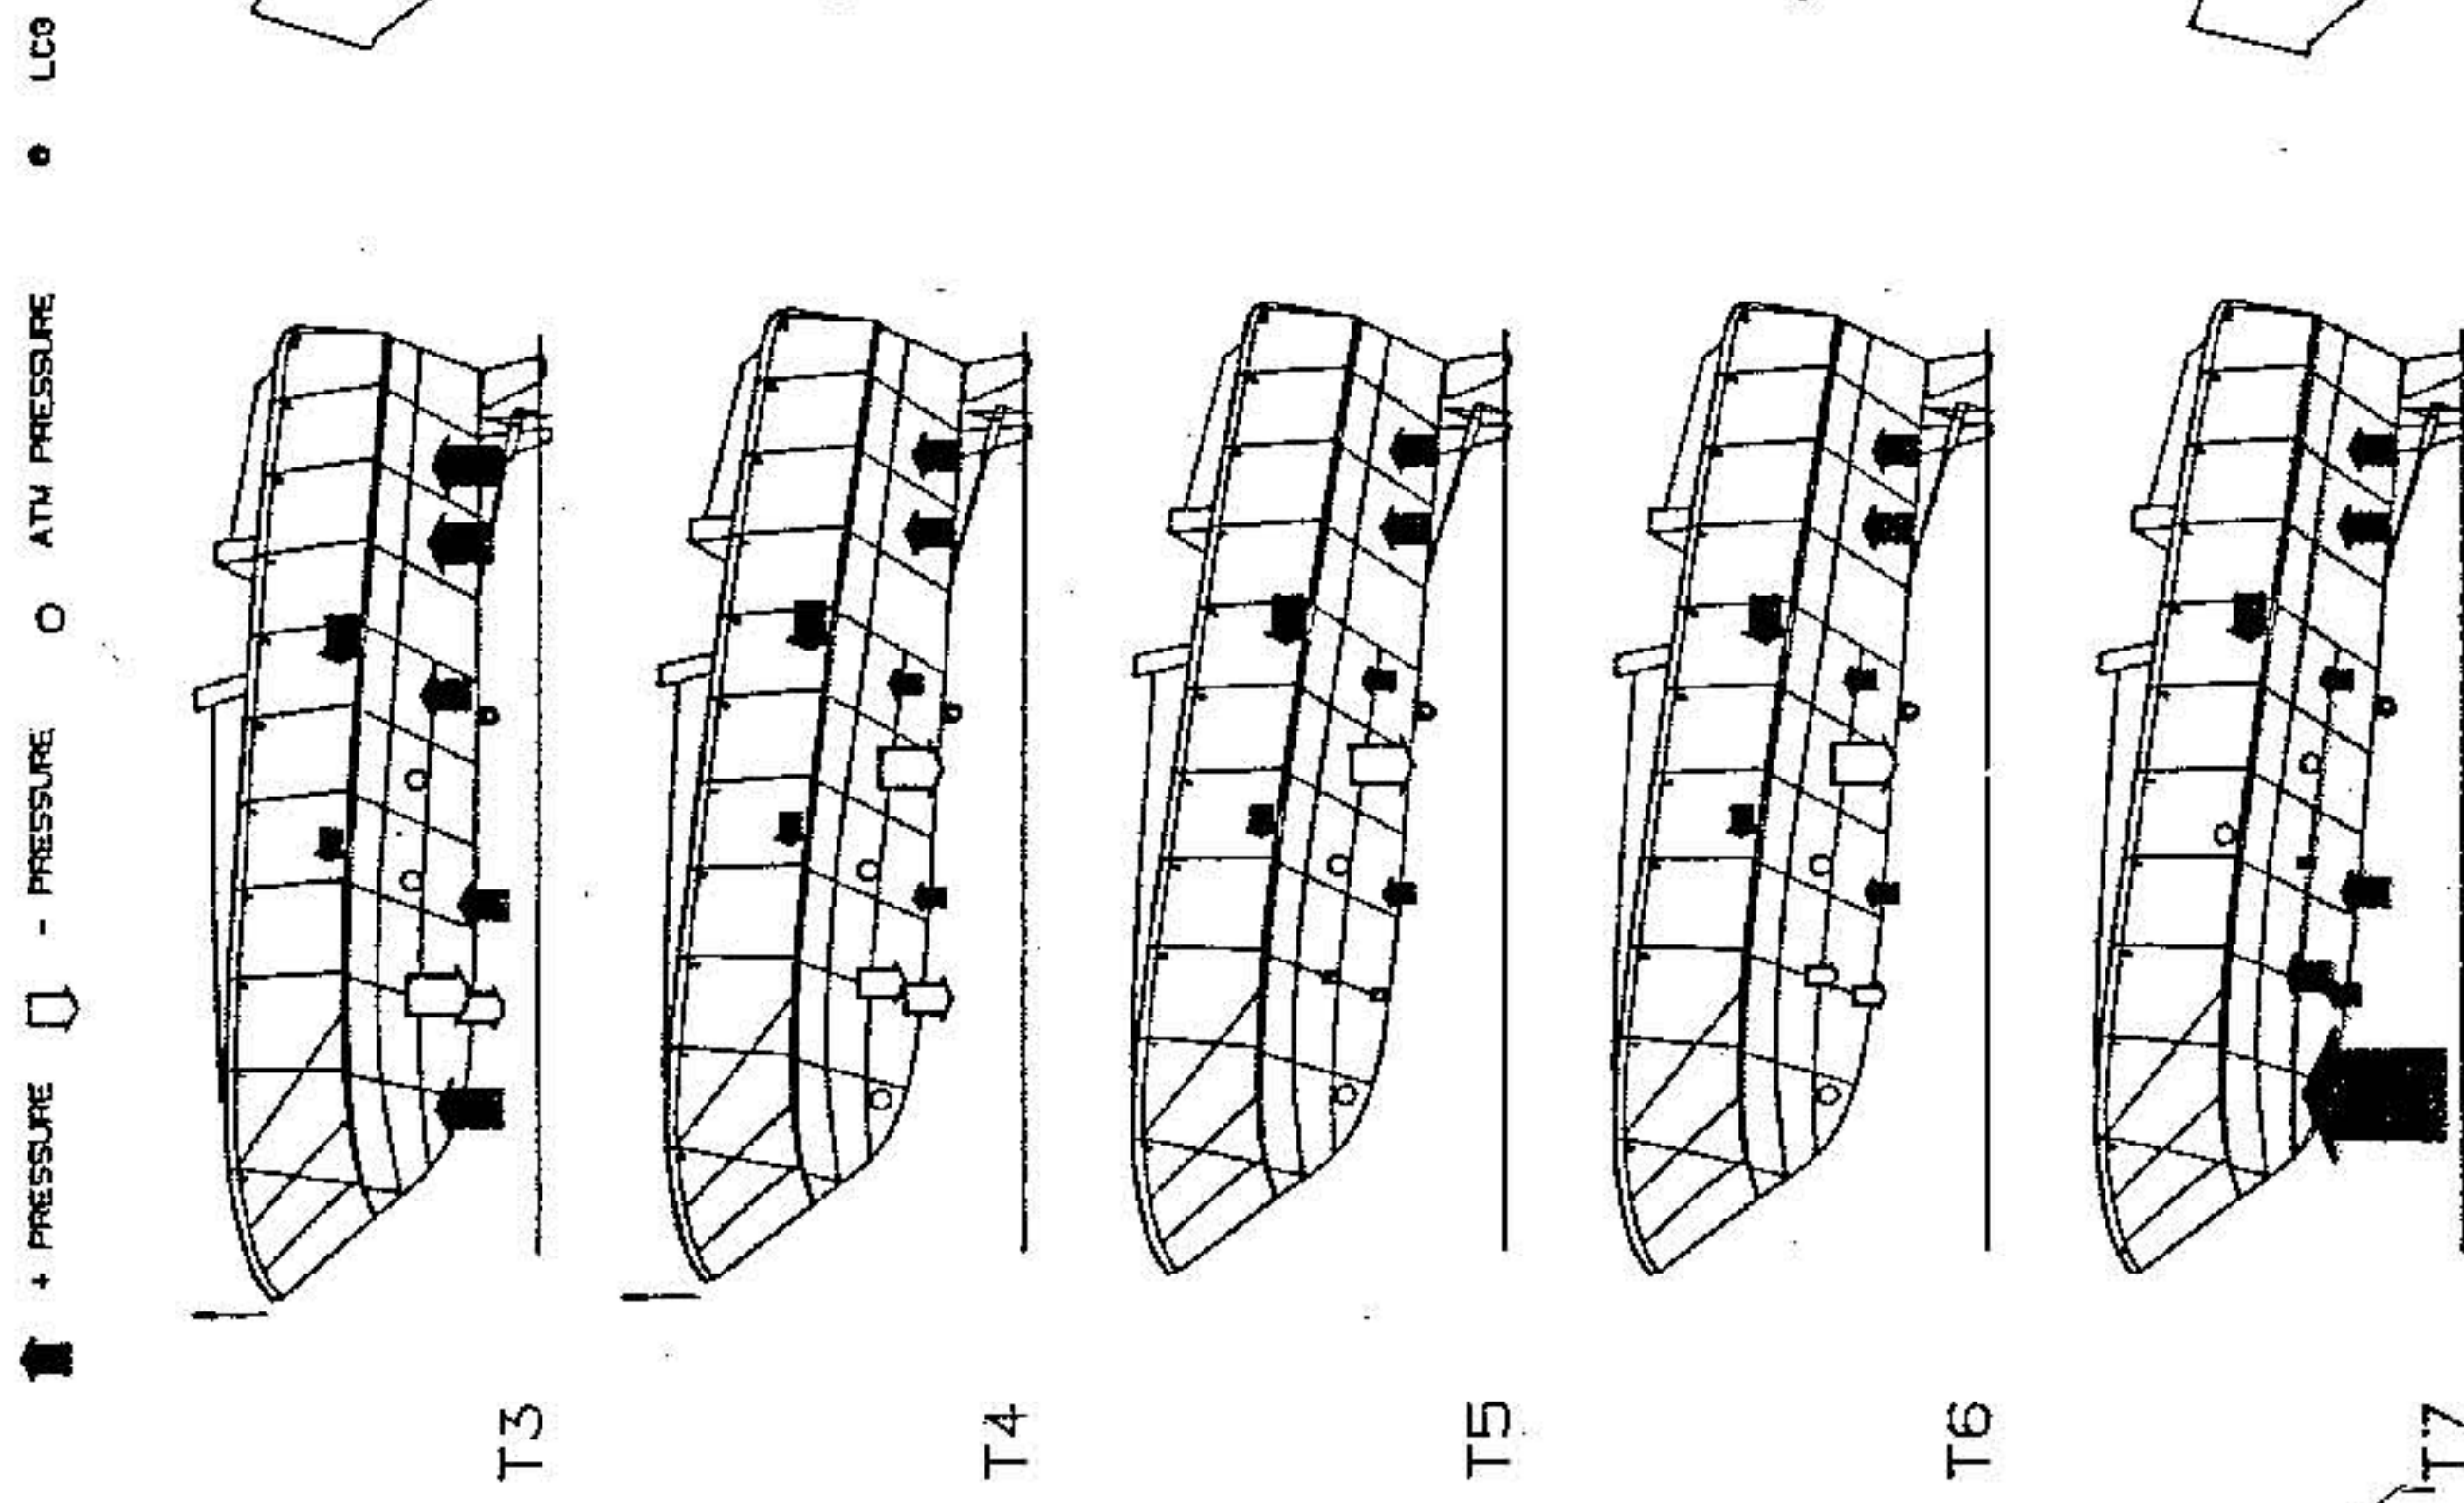
Fig. 30 Pictorial view of bottom pressures at times T3-T7

T7 (negative pressures dissipate; roll follows rudder angle). At time T7 the negative pressures at transducers 2, 3, and 8 have dissipated and gone positive. Speed is at 18 knots. The

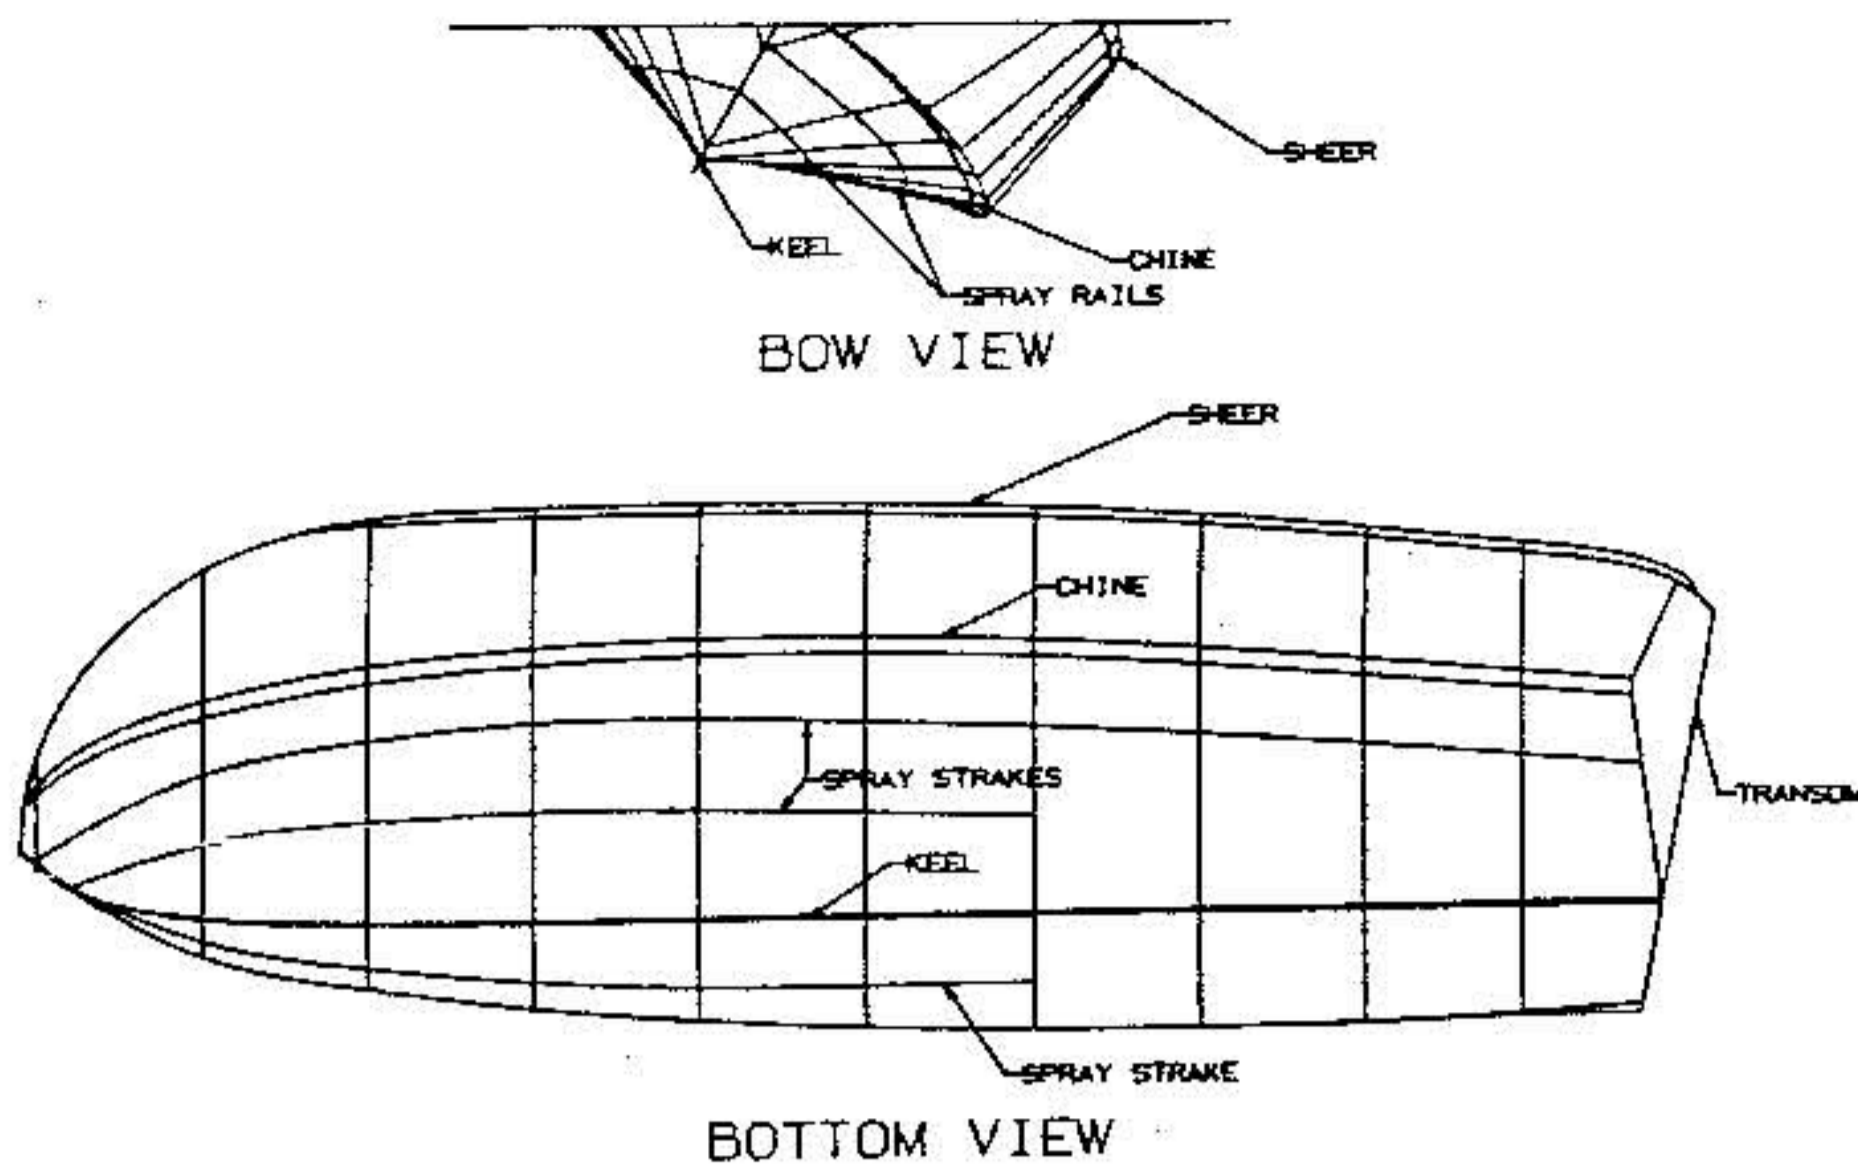
Fig. 32 SRB hull form as modeled for potential-flow model

The hull form of the SRB was modeled for input to the program, in an attitude of 30 deg of heel to port and 1 deg trim, bow down, as shown in Fig. 32. This attitude was approximately that measured while the craft was in the "unstable" mode. This technique was quite tedious since the surface to be modeled has to be divided into discrete areas and the offsets of the corners of these areas found. A total of 192 individual points were input, with the density of points per unit surface greater near the bow. These were then rotated into a coordinate system such that the waterplane corresponded to the X-Z plane of the model.

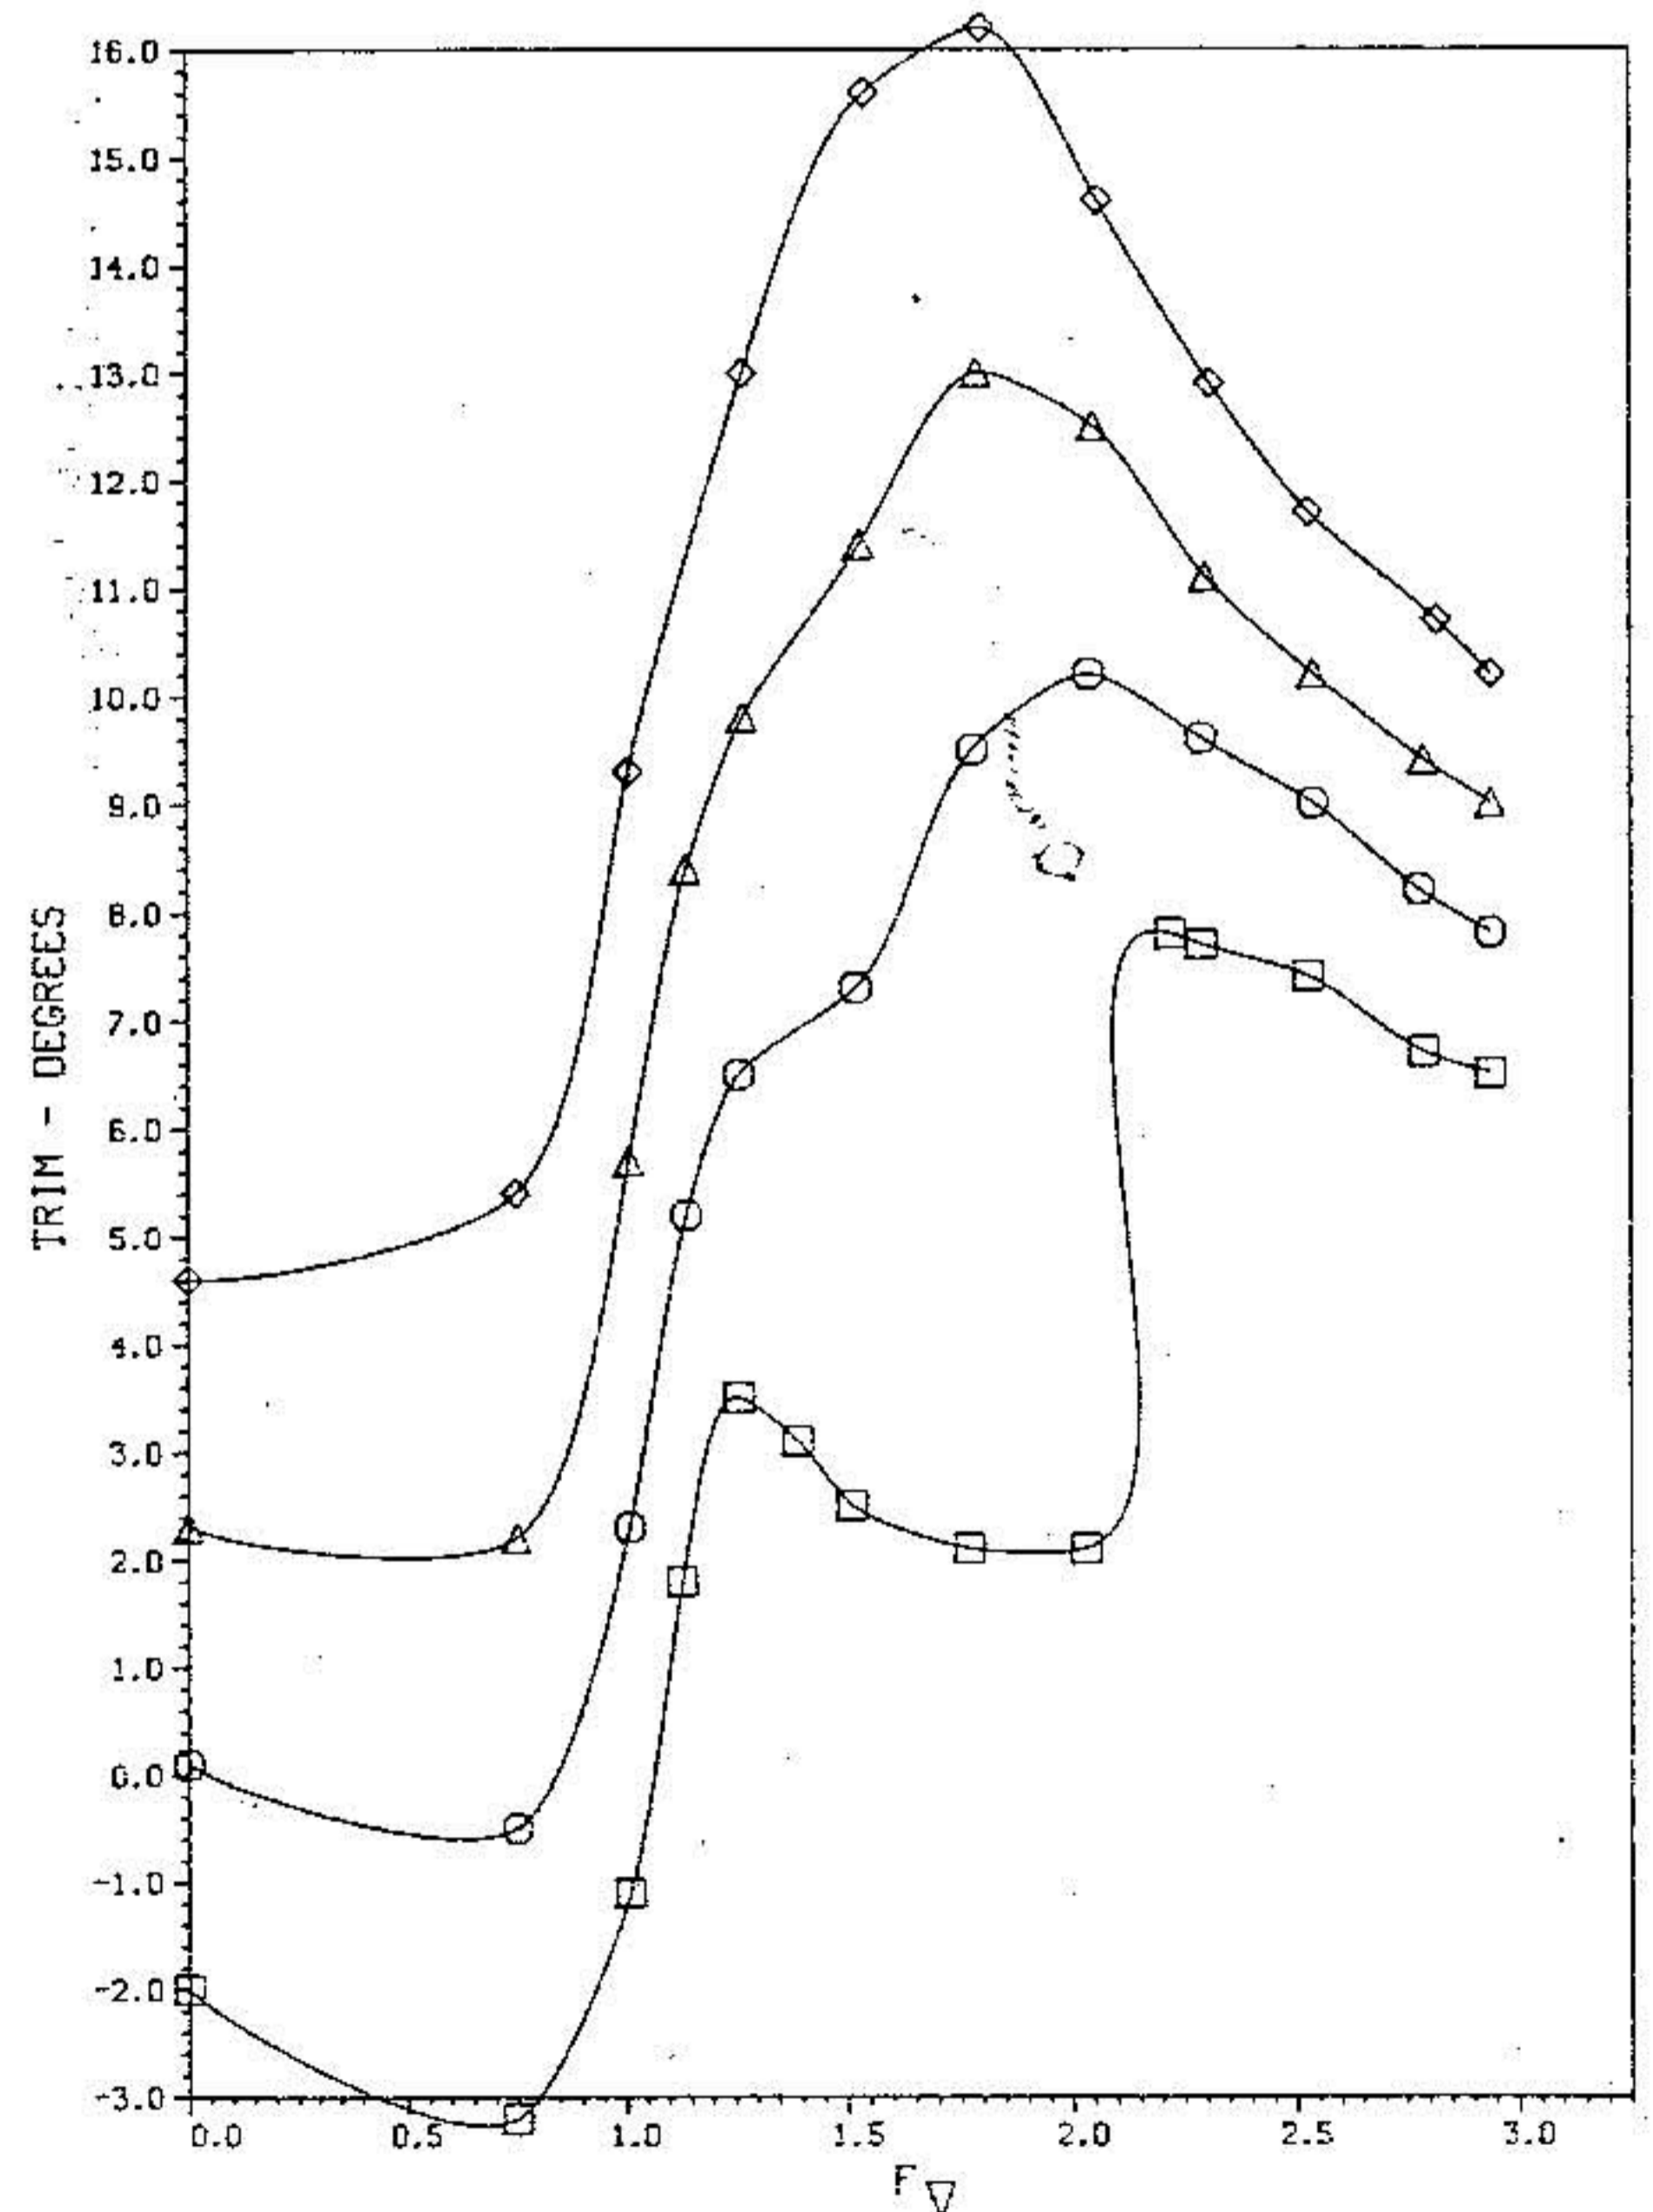
Fig. 34 Series 62 (25-deg deadrise) trim versus speed, Model 187

It was also noted that the two boats first described had an unusual trim-versus-speed curve. The trim would dip slightly as speed was increased, and then begin to increase at volume Froude numbers between 0.5 and 1.0. What was unusual was that above a Froude number of 1.25, the trim would drop sharply, then rise to its maximum angle at a Froude number of about 2 and then drop again. This has one more hump in it than the normal planing boat speed-trim curve. Figure 34 illustrates speed-versus-trim curves for a model test of a 25-deg deadrise planing hull drawn from data presented in [24]. An extreme example of this behavior can be seen for the curve of the model with the LCG at the center of the planing area, labeled "0% Lp." The curve labeled "12% Lp" shows what would be considered a normal trim curve. It should also be noted that this first hump in the trim curve is accompanied by large increases in resistance with decreasing trim, just the opposite of what happens at higher Froude numbers.

It is interesting to note that this anomaly in the curves appears only for combinations of forward LCG's and heavily loaded bottoms, not only for this series of tests, but also for those reported by Clement and Blount [25]. The range of variables where this occurs is for a bottom loading coefficient less than 5.5, with LCG at or forward of 4% Lp aft of the centroid of the planing area, and is most severe when both of the characteristics are in the range, as illustrated in Fig. 34.

All of these effects are a function of speed and displacement. It is apparent that an acceptable hull form at one speed or displacement may not be suitable at an even slightly higher speed or increased displacement. Until more definitive research can be done, it is recommended that references [24] and [25] be consulted and that combinations of coefficients that lead to a double hump in the trim-versus-speed curve be avoided.
