A Case Study of Dynamic Instability in a Planing Hull

Louis Codega¹ and James Lewis¹

Soon after introduction into service, a class of high-speed planing boats began to exhibit a dynamic instability that manifested itself in the craft trimming by the bow, rolling to a large angle of heel to port, and broaching violently to starboard, all within five seconds. This behavior, which occurred within the craft's normal operating envelope, could not be attributed to operator causes and resulted in unacceptable operating restrictions being placed on the craft. After a number of unsuccessful attempts to remedy the problem, an investigation to research possible causes was undertaken. Concurrently, a test boat was instrumented to quantify its behavior and, most importantly, to record the hydrodynamic bottom pressures acting while this phenomenon occurs. The craft is described and initial attempts at solving the problem are outlined. The results of research on this type of phenomena in both planing craft and flying boats are presented. The instrumentation system, complex for this size craft, is detailed and the test procedure described. The results of the full-scale tests are given, along wit

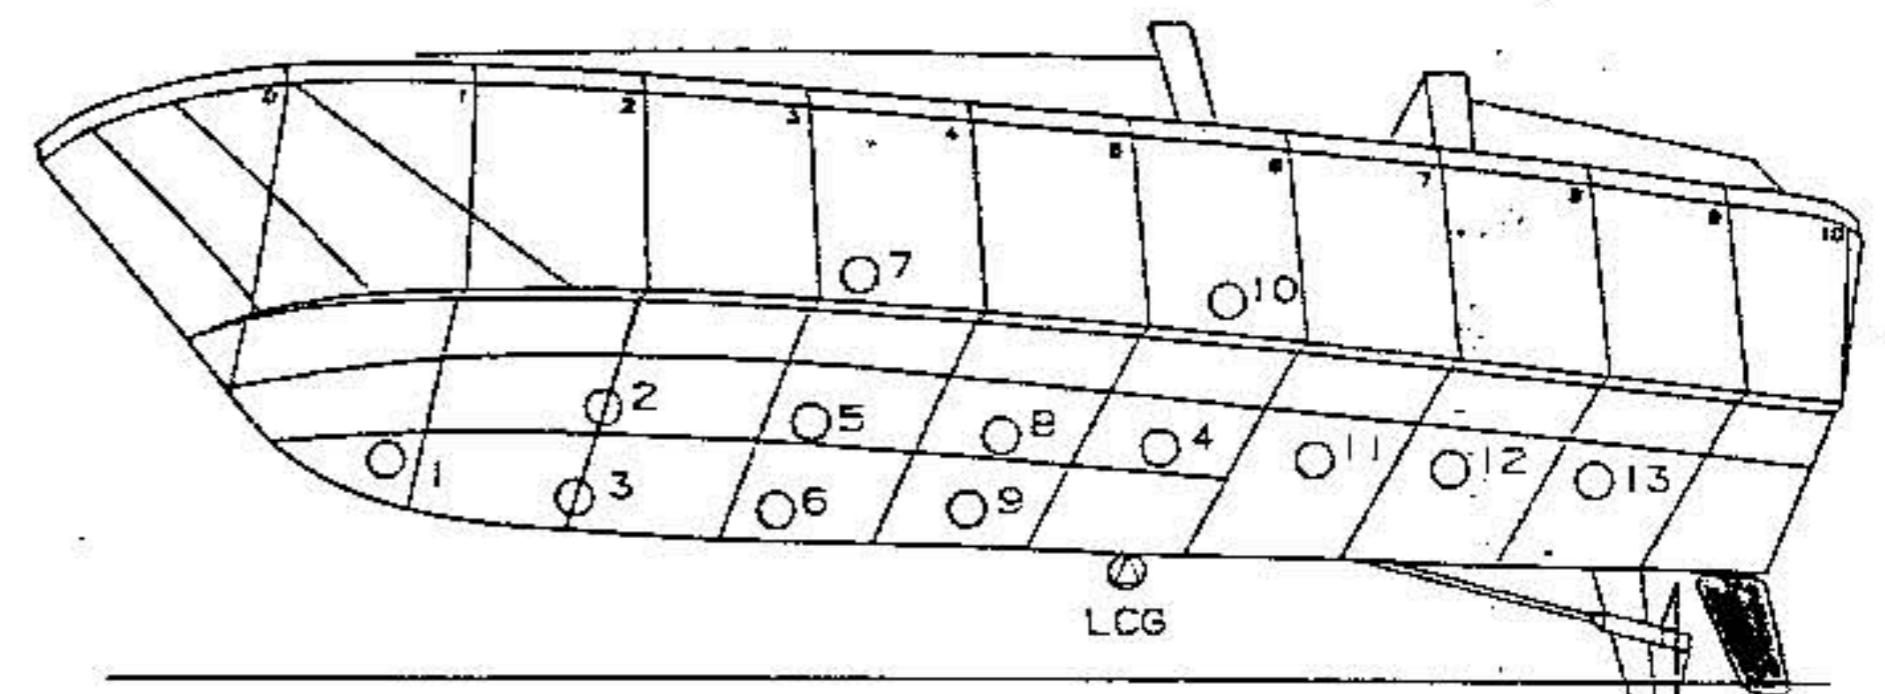
Fig. 15 Location of pressure transducers

The vertical gyro, recording instrumentation and signal conditioning units were located in the boat's aft compartment to minimize any effects of shock due to bow slamming. Triaxial accelerometers were mounted on the centerline at stations 1 and $9\frac{3}{4}$. The Kenyon speed sensor was located at station 8 port side. Shaft rpm was measured using a magnetic pickup to sense the frequency of rotation of the eight bolts on the shaft's coupling flange. Shaft torque was measured with a strain-gage telemetry system, and hull bottom pressures were measured with 13 flush-mounted pressure transducers distributed along the port bottom as shown in Fig. 15.

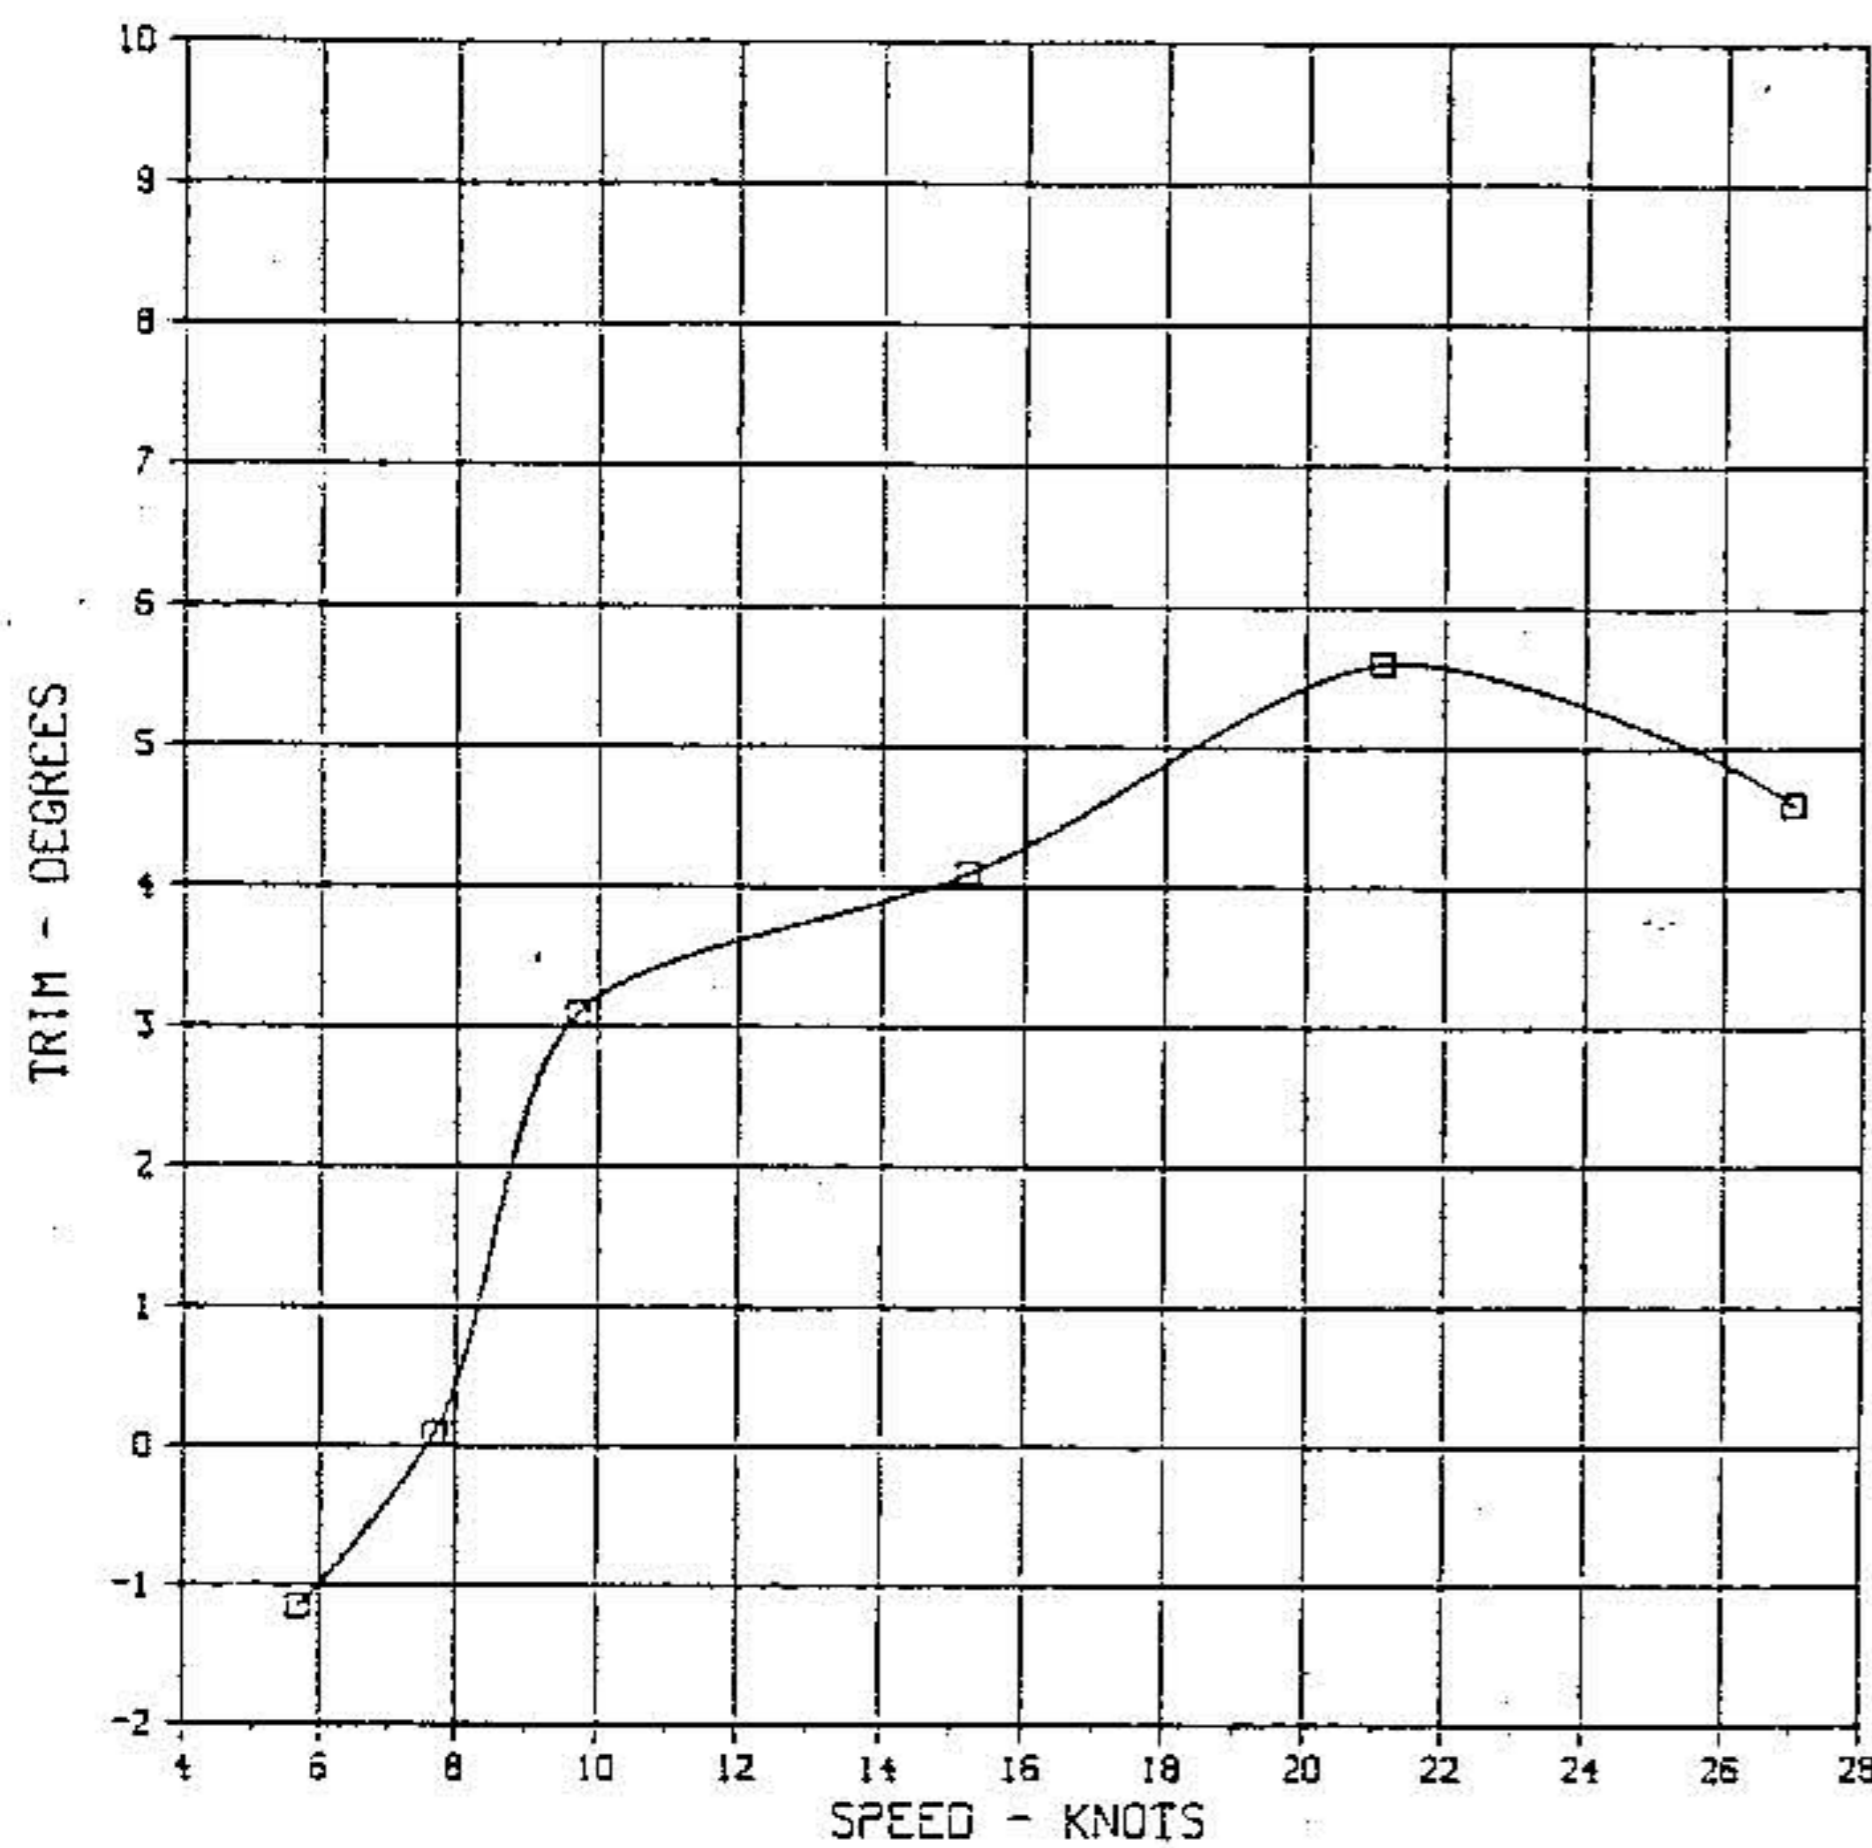
Fig. 16 Plot of trim versus speed

Calm-water test. The speed-versus-trim characteristics measured during the calm-water test are plotted in Fig. 16. The average bottom pressures at constant speeds are listed in Table 2. The natural roll and pitch periods were found to be 2.3 sec and 1.9 sec, respectively.

The bottom loading coefficient of the SRB is 5.4, the LCG is at the centroid of the projected planing area, and the boat operates at a volume Froude number of 2.6. The trim curve, Fig. 16, does not show a well-defined double hump, but does have a point of inflection at a Froude number of 1.7. The similarity between all of these cases is striking.

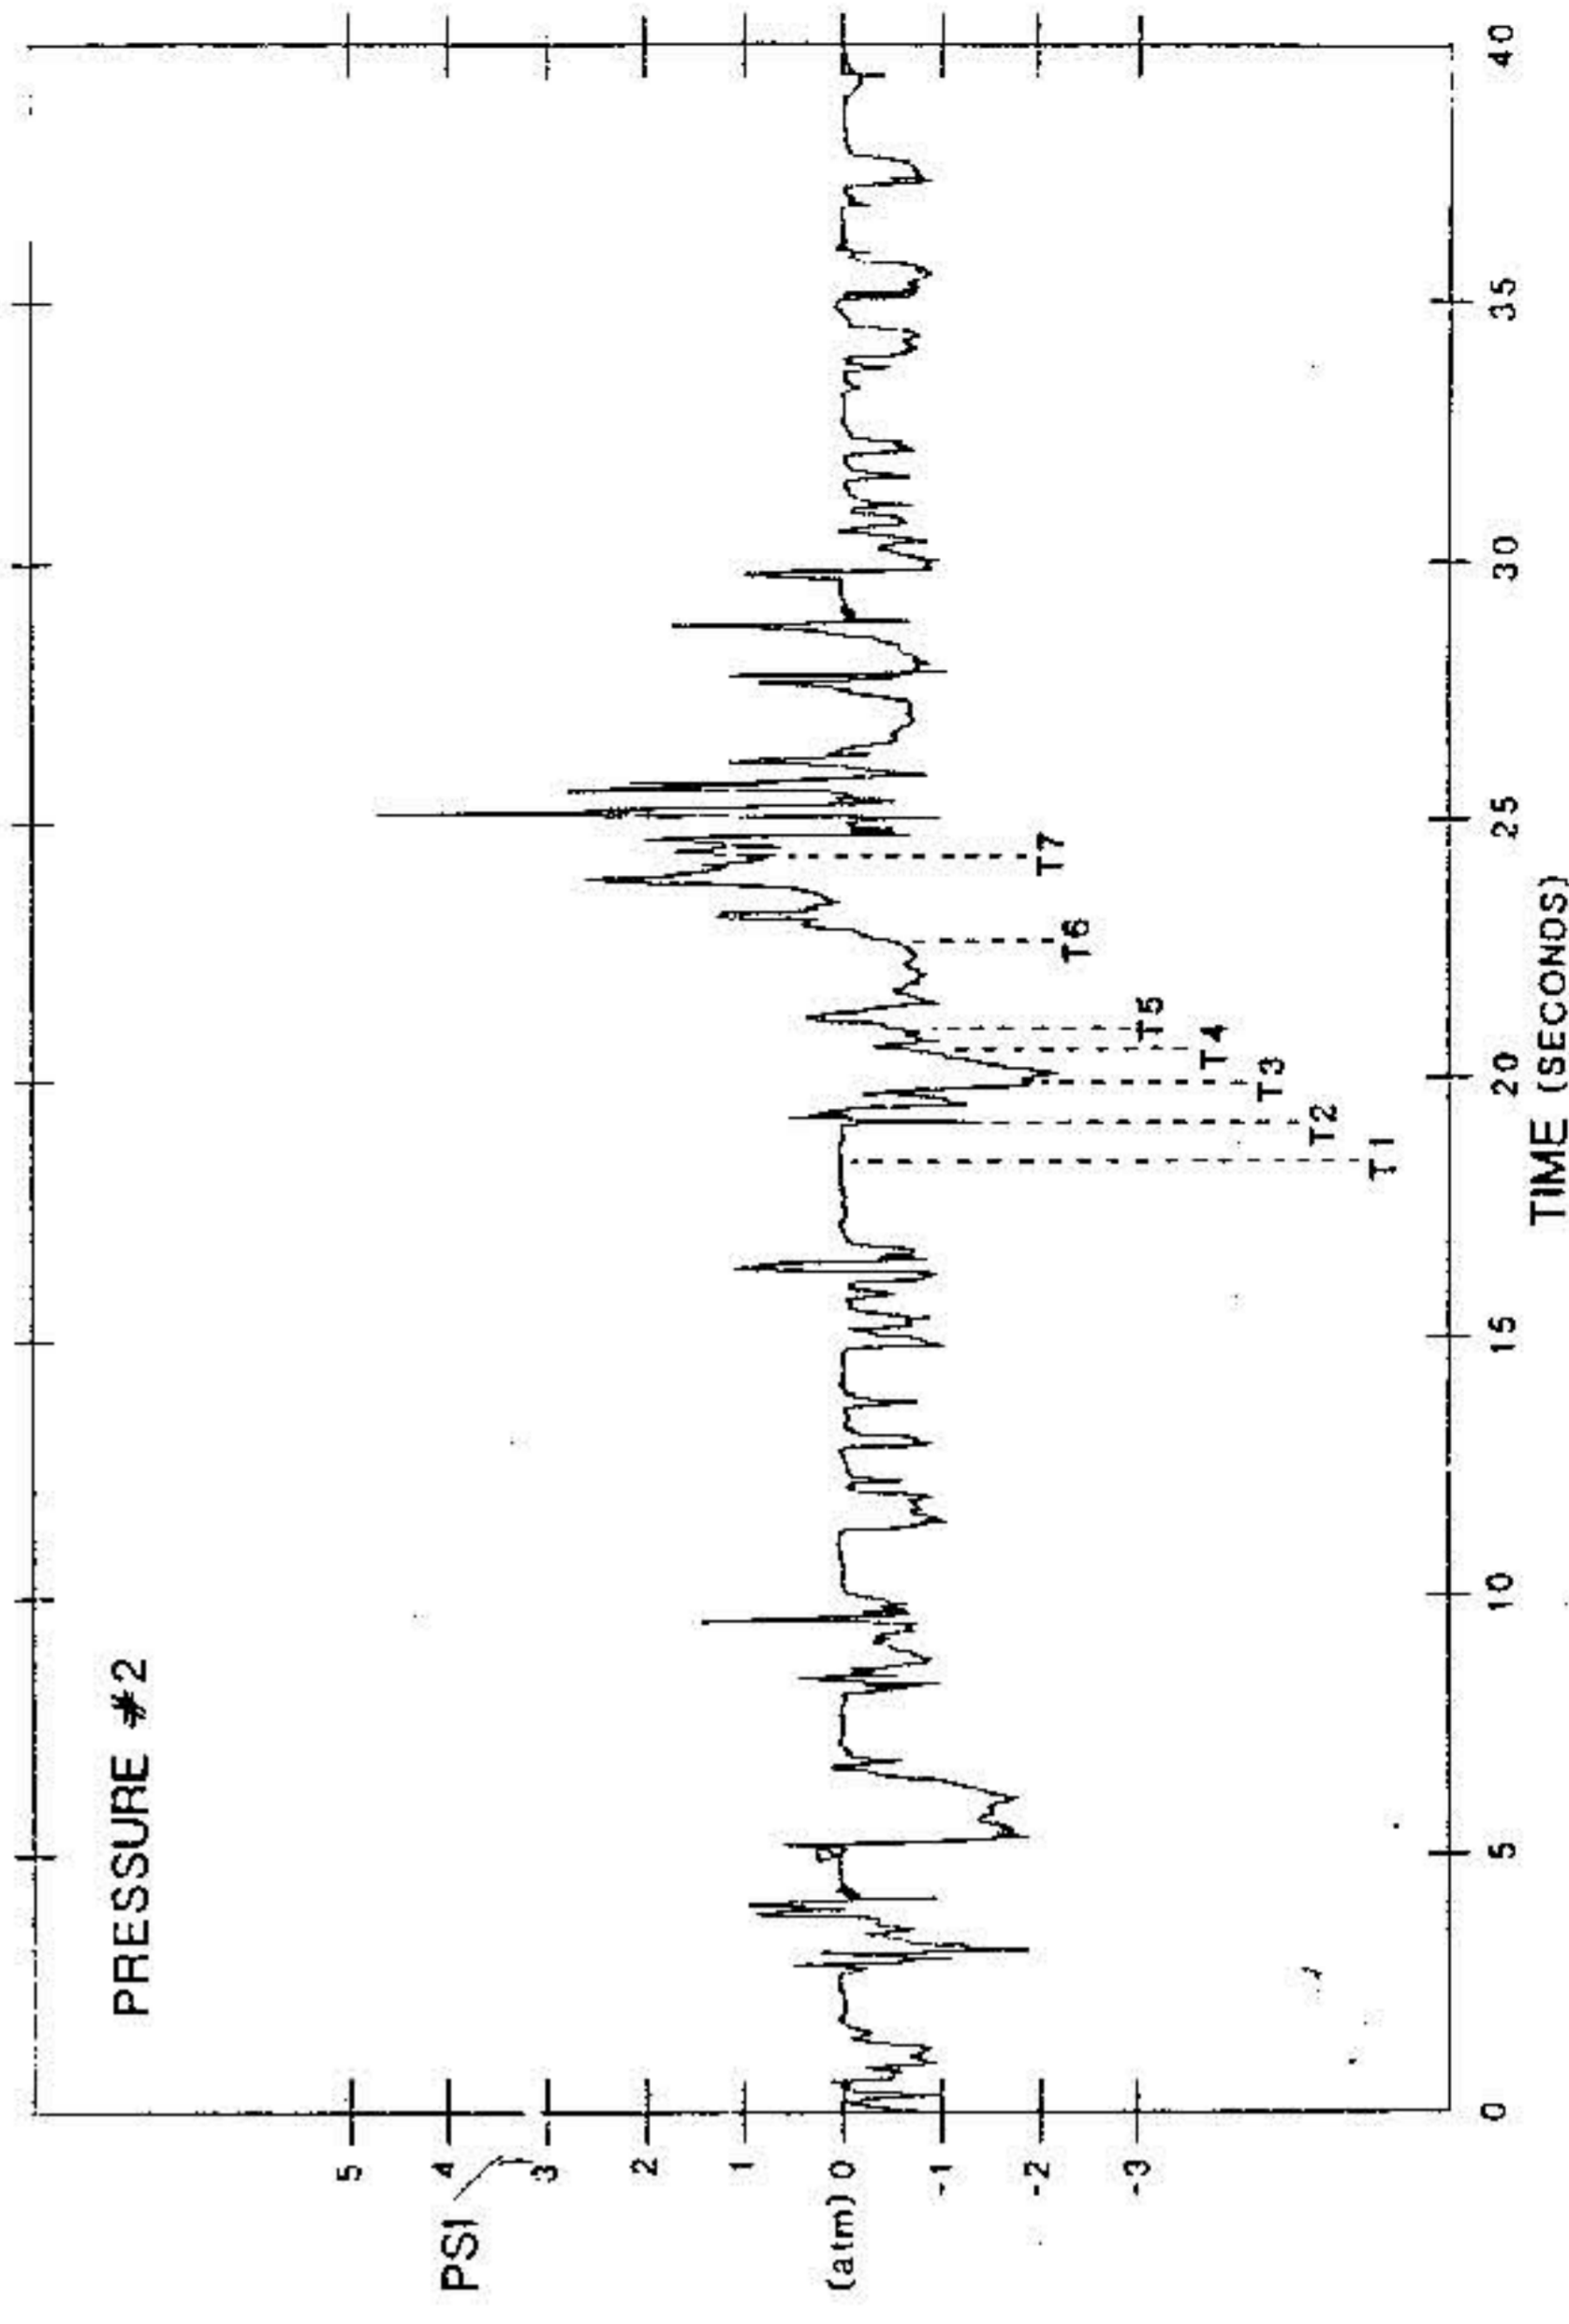
Fig. 19 Recorded data for pressure transducer No. 2

T6 (negative pressures decrease). At time T6 pressure transducer No. 1 clears water again. The -2.5 psi pressure at transducer No. 8 decreases to -1 psi and the negative pressures at Nos. 2 and 3 start decreasing. The roll decreases from 45 to 21 deg.

T7 (negative pressures dissipate; roll follows rudder angle). At time T7 the negative pressures at transducers 2, 3, and 8 have dissipated and gone positive. Speed is at 18 knots. The

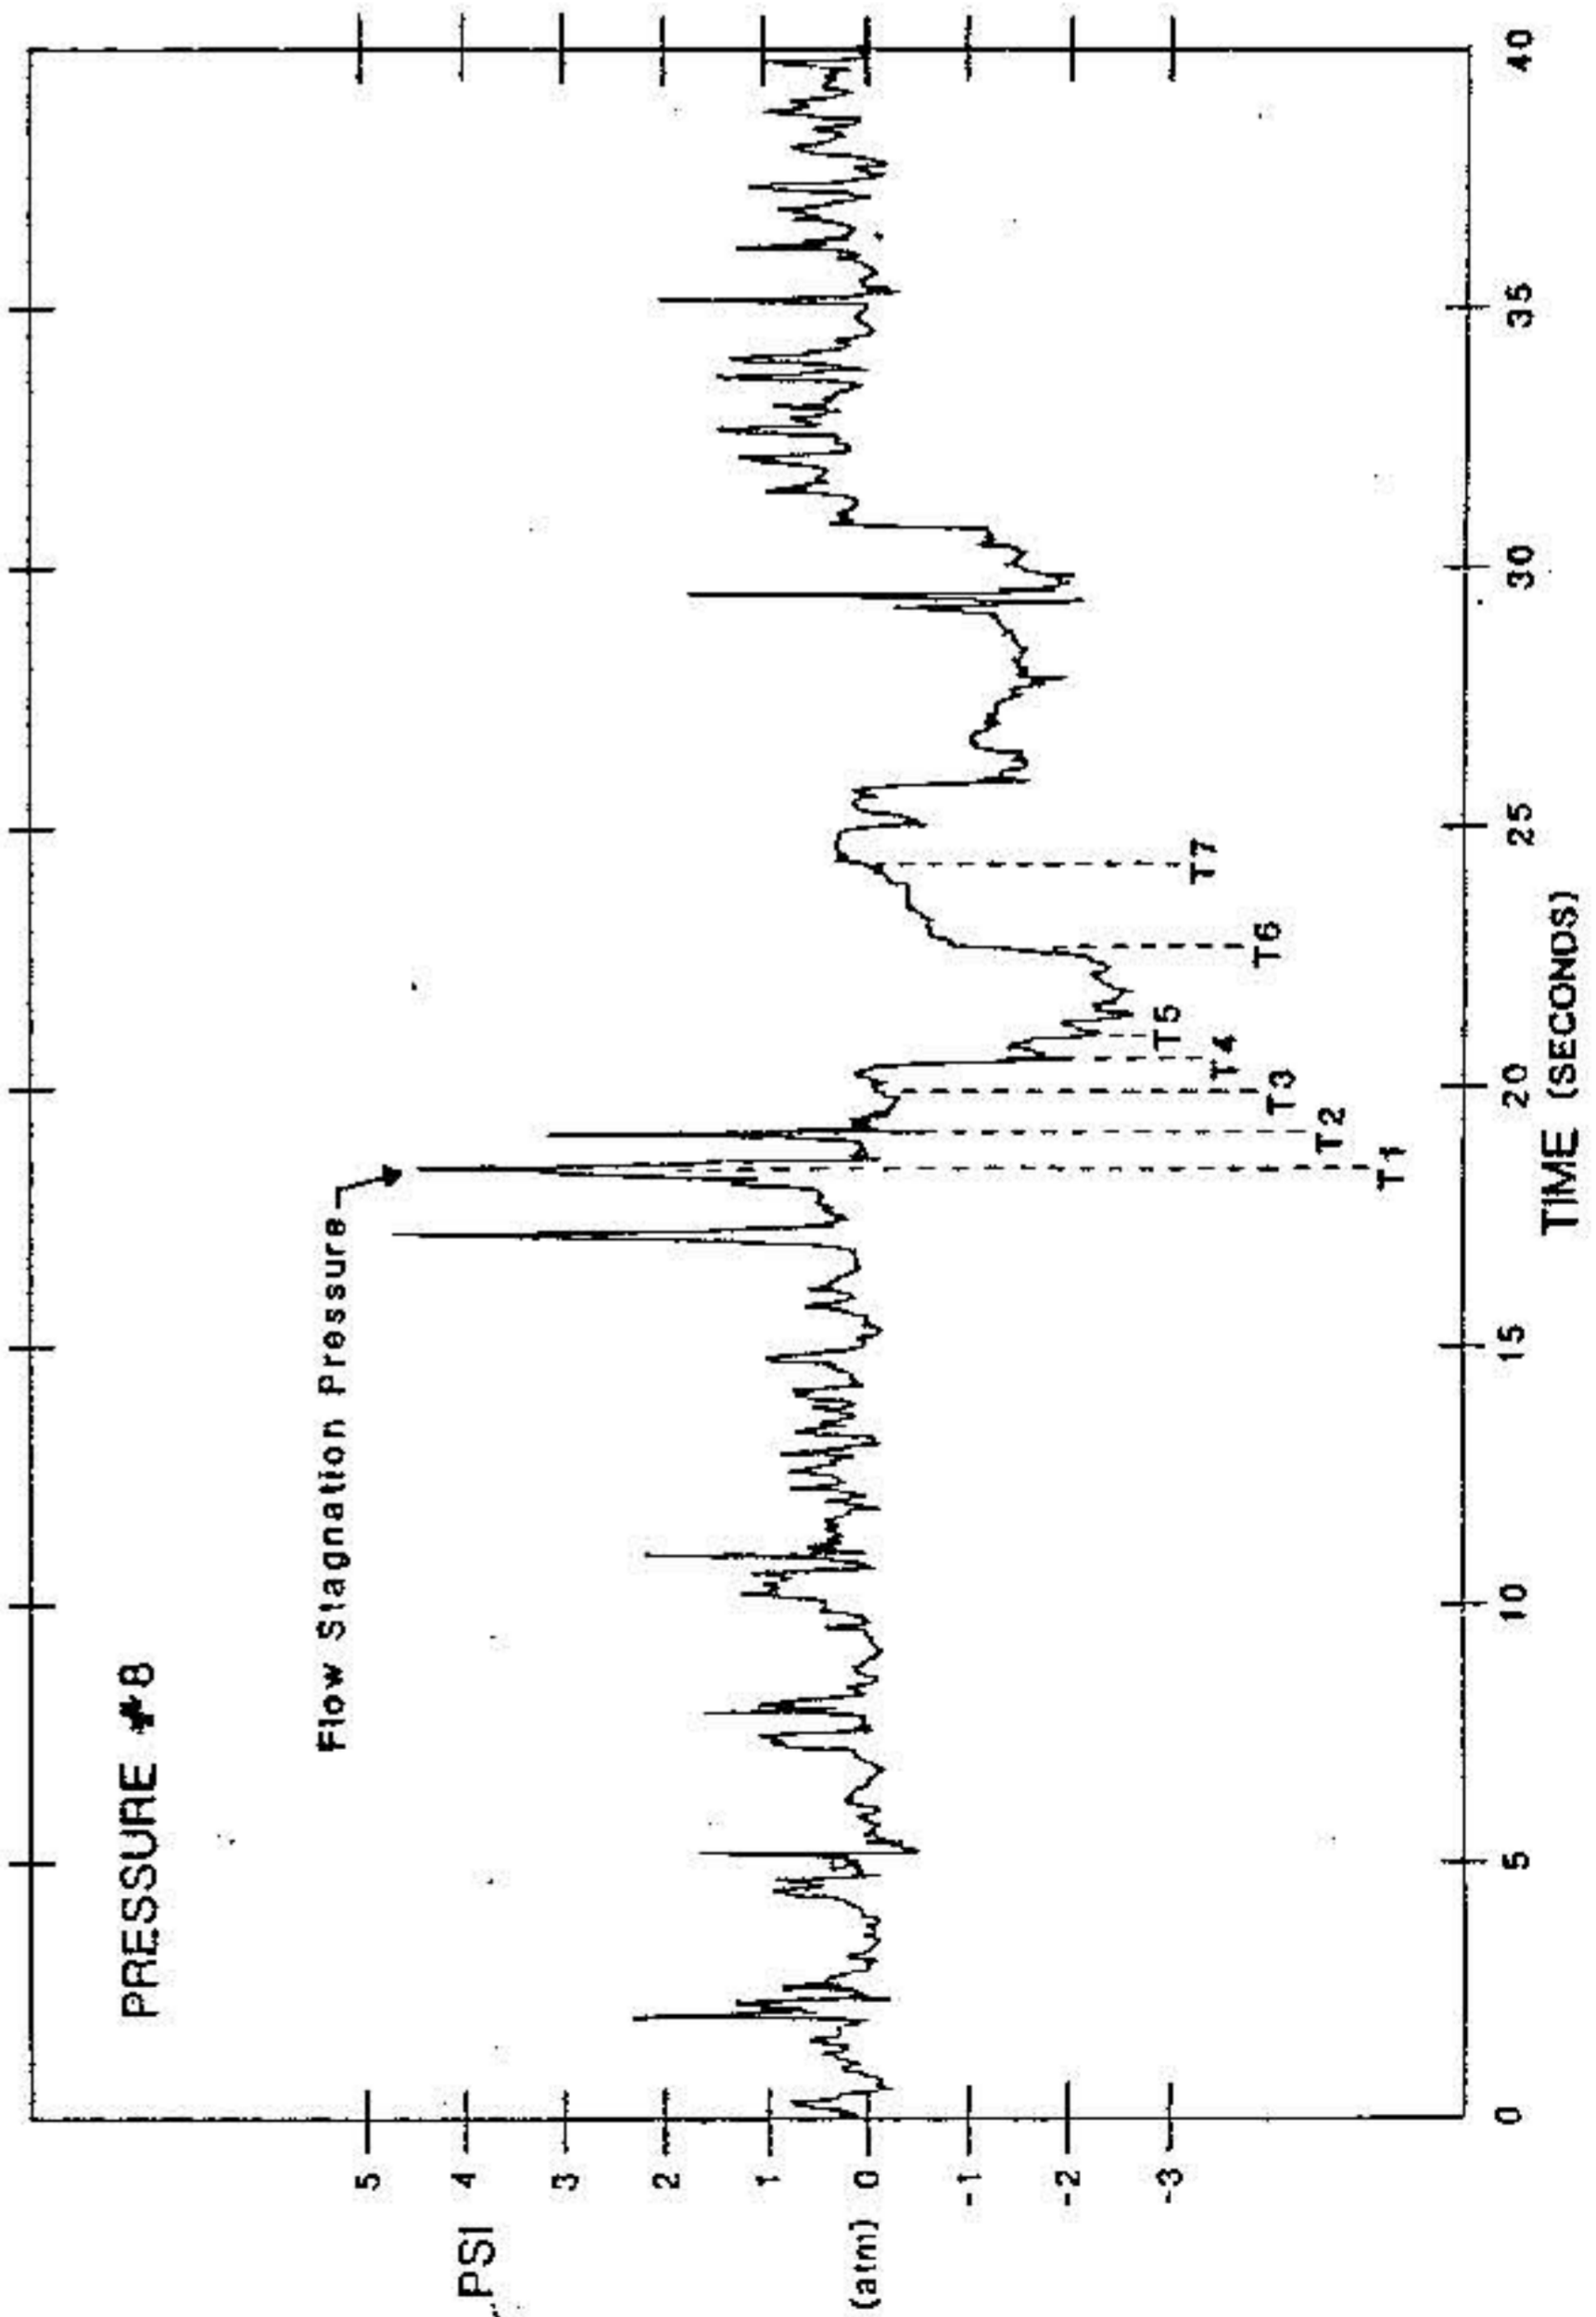
Fig. 25 Recorded data for pressure transducer No. 8

rudder is setting left 13 deg and appears not to be the major cause of the port heel. Roll angle follows the rudder angle for the rest of the data record. The coxswain continues to vary the throttle and rudder angle in an effort to keep the boat in the unstable condition. Pressure transducer No. 8 returns to -1 psi for approximately 5 sec but appears to have little or no effect on the roll.

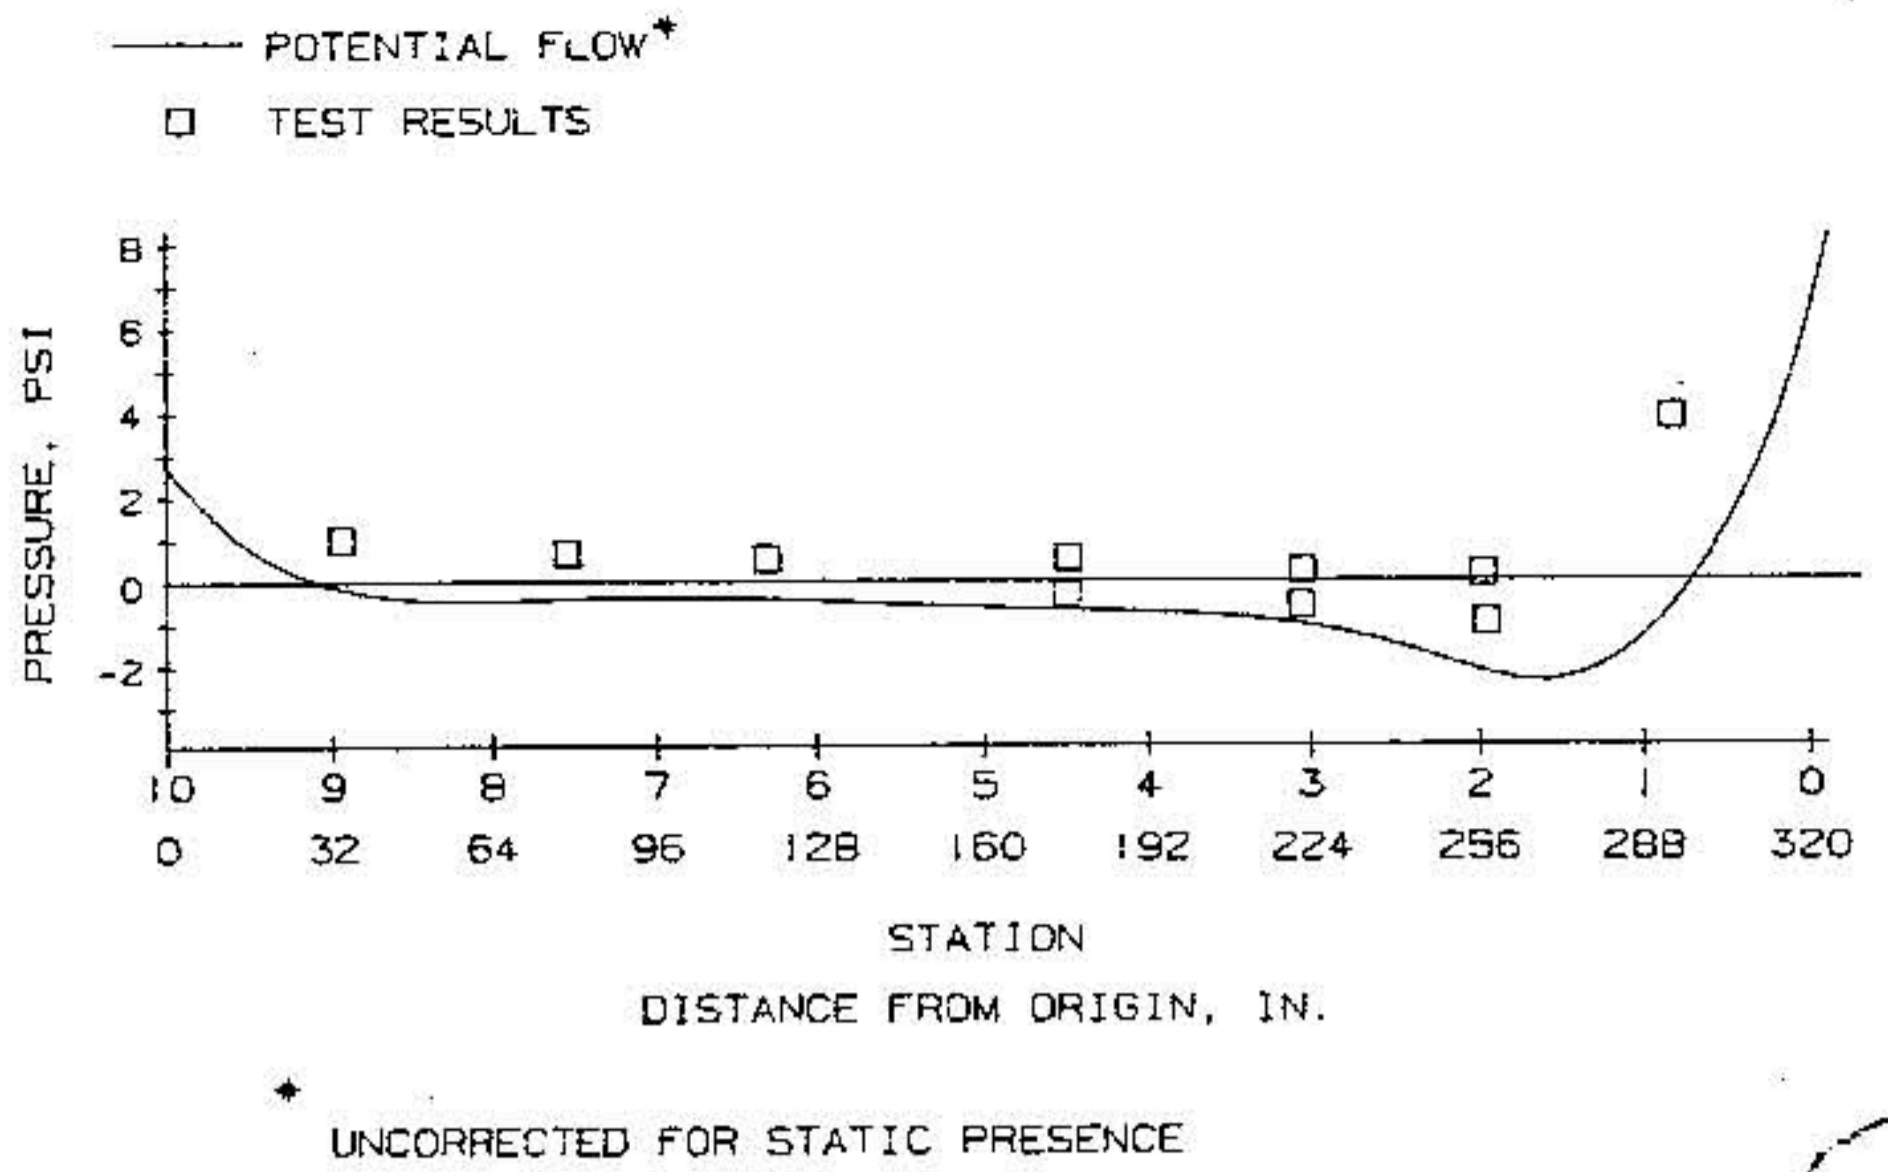
Fig. 33 Results of potential flow model

The model was exercised both as a single submerged hull and as a body symmetric in the X-Z plane. The pressure differences between these two calculations were quite small in the area that was of most interest, that is, the port side from the chine to the keel. The results of the pressure calculations in this area are condensed into Fig. 33 and superimposed on experimental pressure measurements taken while the boat was in approximately the same attitude. The results are similar to those for the body of revolution, showing higher pressure regions forward and aft, with a large low-pressure area amidships.
